Severe marine corrosion within pipe suction throat led to corrosion/erosion damage and a hole in pipe, reducing lift pump effectiveness.

Repair and protect pipe to avoid new pipe section purchase.

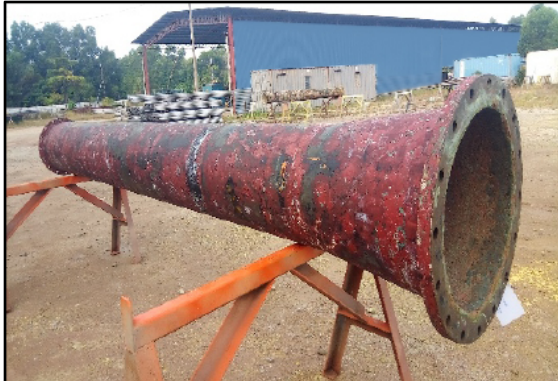
High flow of raw seawater caused the nickel aluminum bronze pipe column to erode and corrode.

Pipe section after hot water pressure wash.

- Hot water pressure wash.
- Grit blast to Sa 2.5 with 3 mil (75 µm) angular profile.

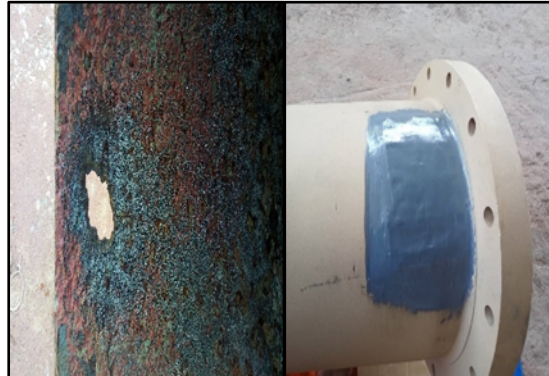
Pipe hole on left and patch section on right.

- Hole was patched with **ARC 858** and steel mesh at internal and external sides of hole.
- Covered external and internal faces with **ARC 858** and then top-coated with three coats of **ARC SD4i** to internals. Two coats to externals.

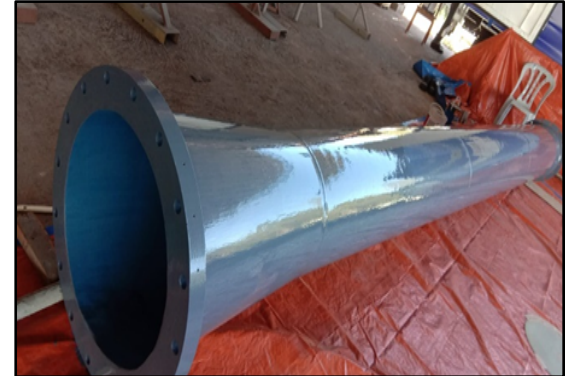
Customer satisfied with repair and the performance of the coatings. The repaired solution continued in service without failure.

Completed pipe repair and internal/external coating with **ARC 858** and **ARC SD4i**.
