Challenge

Turbine metal loss by cavitation and microbiologically induced corrosion (MIC).

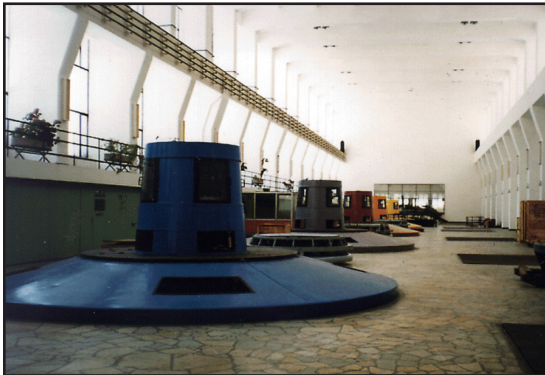
Biological corrosion to shaft; and cavitation damage to housing. Significant metal loss in both areas.

Reduce equipment reliability
