Challenge

- Rebuild 1949 pump to near new in less than 2 months with no modification to piping

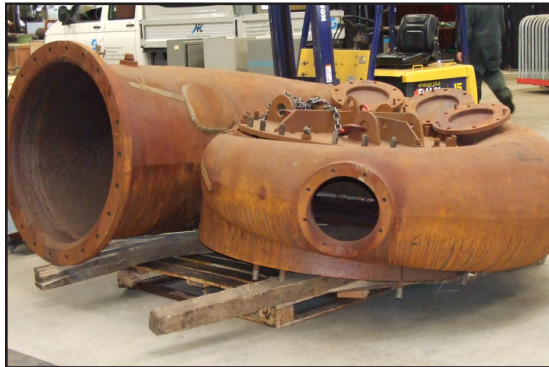
Severe corrosion/erosion in volute, backplate, and other wear parts as well as irreparable impeller with broken blade.

Cast Steel pump built in 1949! With a diameter of 2,5 meter, 30 m³/minute

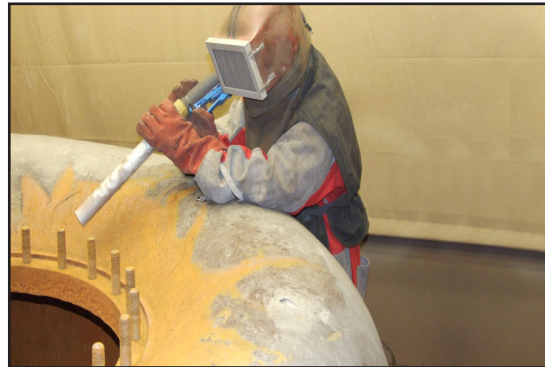
Thorough surface preparation

- Grit blast to Sa 2.5 with 3 mil (75 µm) profile

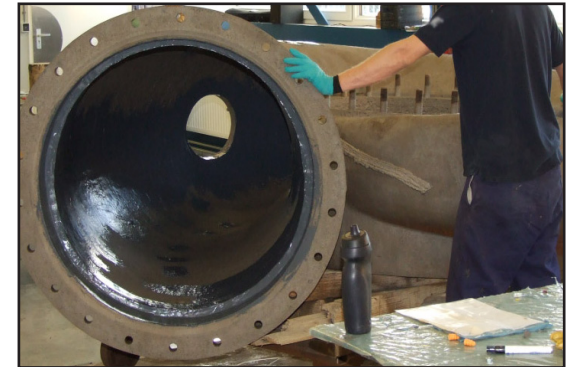
Multiple ARC products used to address various wear levels and surface enhancement

- Rebuild volute and parts using ARC 858
- Machine to tolerance as required
- Apply ARC BX1* and ARC BX2* and MX1 to high wear areas
- Apply 2 coats ARC 855 total DFT of 1000 µm
- Apply 2 coats ARC S2 total DFT of 500 µm to outside of pump
