Challenge

Ash dewatering bins

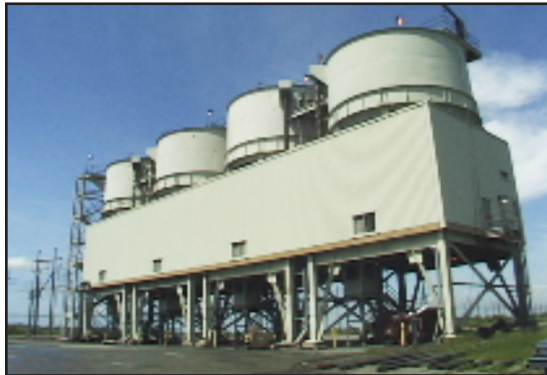
Failure of a PU liner in 2 years resulted in pitting and corrosion, which increased friction and caused sludge hang up in bottom ash dewatering bins.

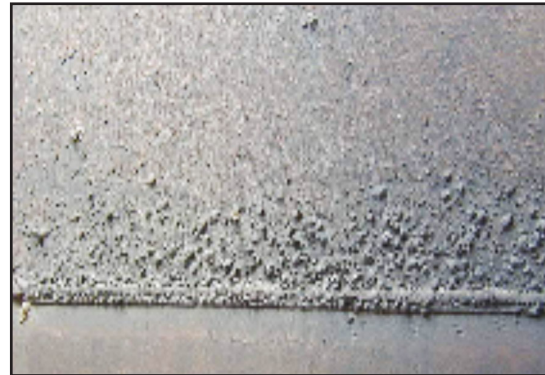
Blistering of the existing urethane liner

- UHPW blast surfaces to remove urethane and reduce chloride levels
- Replace identified plate
- Grit blast to Sa 2.5 with 3 mil (75 µm) profile

1. Apply **ARC 858** to weld seams and pitting
2. Apply 3 coats of **ARC 855** for anti-corrosion and hang-up reduction ~DFT: 60 mils (1.5 mm)

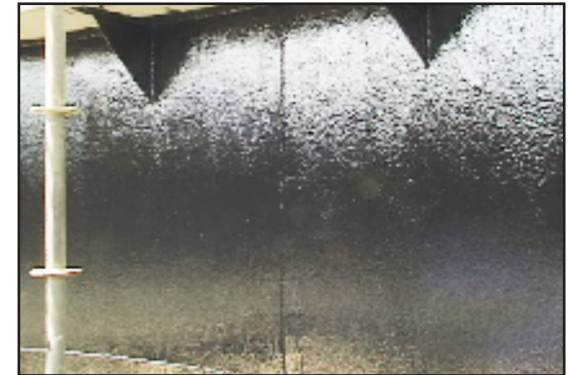
- Ash hang-up reduced to < 3%
- Pitting corrosion halted in all bins (4)

ARC 855 completed coating
