Challenge

The exhaust fan required unscheduled weld repairs every 2 months and complete replacement after only 6 months. Cost and service life were unacceptable.

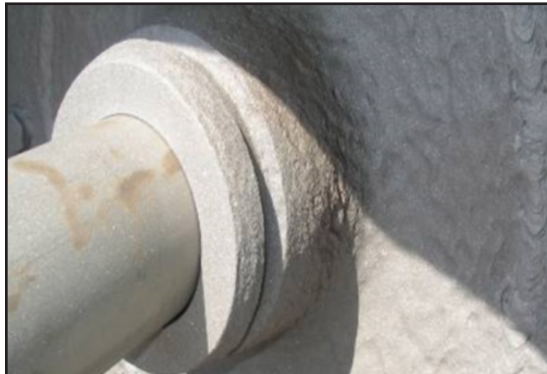
Attack of the fan by the corrosive exhaust gases from smelting operation at 120°C.

Condition of fan rotor after sandblasting

- Dynamically balance fan and adjust as required
- Grit blast to Sa 2.5 with 3 mil (75 µm) angular profile

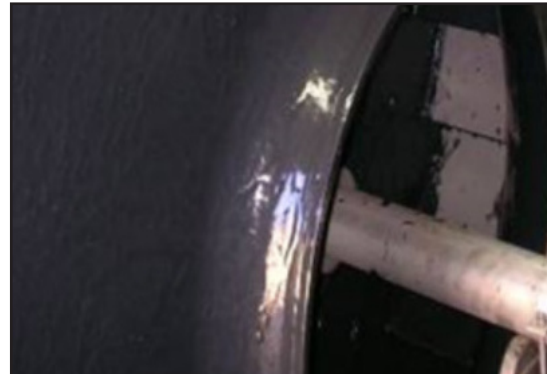
Fan being coated

1. Use **ARC 858** build eroded volute and parts
2. Apply 2 coats **ARC HT-T** to total DFT of 40 mils (1 mm)
3. Statically balance fan

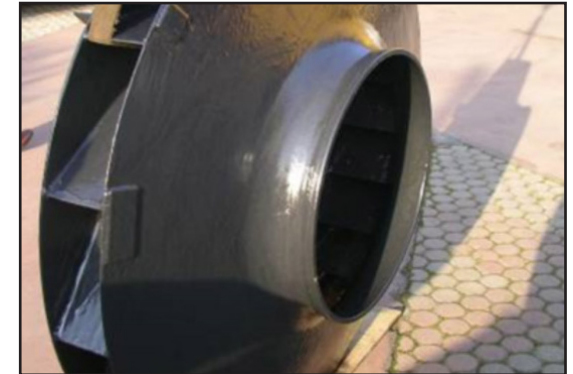
Completed application to 1600 mm fan
