Issue

Concrete encased pump could not be removed for repair. Extensive cavitation and pitting corrosion reduced pump flow performance impacting plant efficiency.

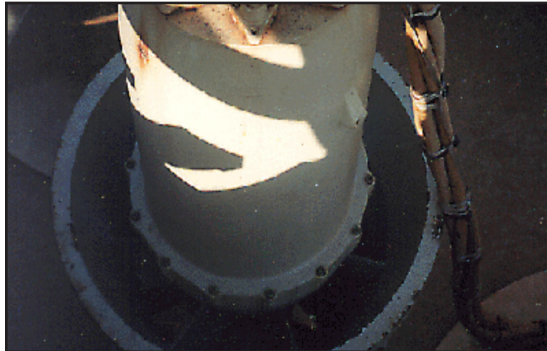
A combination of cavitation and pitting corrosion attacked the pump's cast iron bell housing. Tolerances went out-of-spec due to metal loss of .750" (18 mm). Empirical data indicated pending catastrophic failure lower bell housing.

Three pumps were experiencing this failure

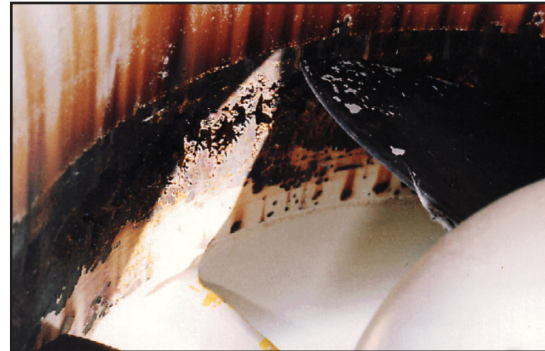
Cavitation and erosion of bell housing

1. Apply **ARC 858** to zones of pitting corrosion and cavitation
2. Apply **ARC 855** in 2 coats to total DFT of 30-40 mils (.75-1 mm)

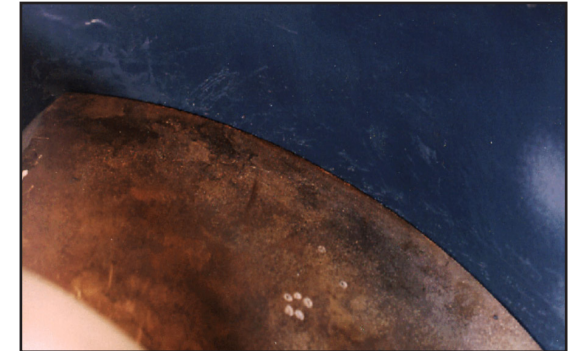
Damaged area repaired with ARC 858
