## Challenge

Plant forced to consider purchase of new stock pump with \$50K cost and 4 week lead time. Downtime associated with replacement had estimated cost of \$300K.

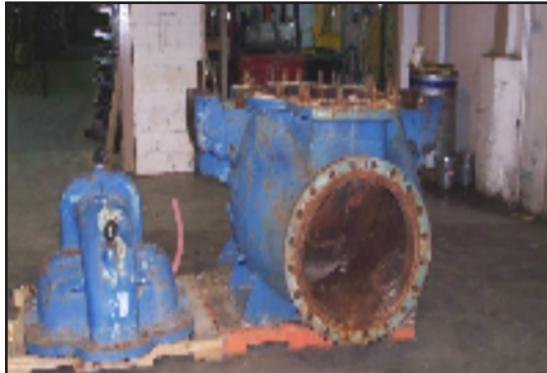
Damaged used pump located at cost of \$20K

Salvaged stock pump

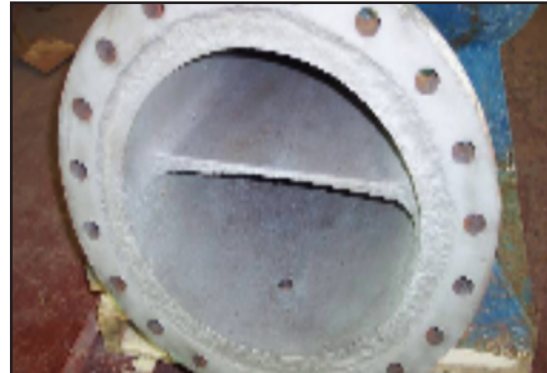
Surface prepared

- Steam clean at 100 bar (1400 psi)
- Grit blast to Sa 2.5 with 3 mil (75 µm) angular profile

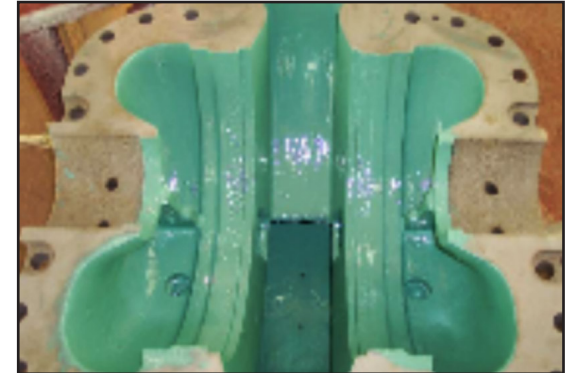
Rebuilt salvaged pump

- Mask sealing surfaces before coating
- Rebuild corroded and pitted sections with **ARC 858**
- Apply 3 coats of **ARC S2** ~DFT: 60 mils (1.5 mm)
