Challenge

Issue

Corrosion occurs at weld seams, requiring welding within 3 years. Loss of screen deck structure can shut down plant.

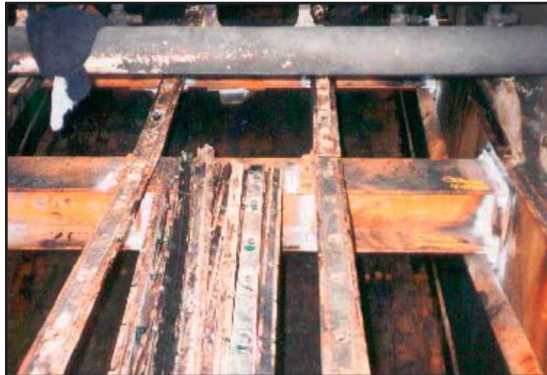
Urethane liners fail prematurely. Acidic wash water combined with erosive particulates attacks exposed steel at weld seams.

Damaged coal screen

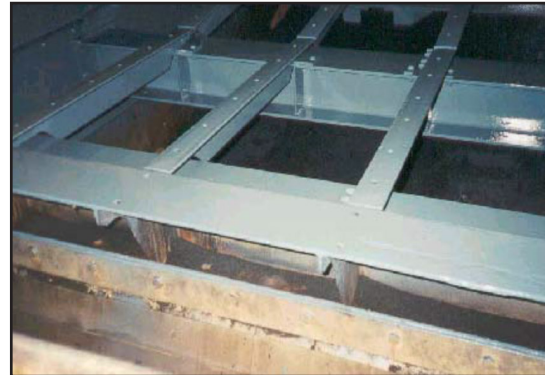
ARC S2 grey applied to coal screen

- Remove remaining urethane liners
- Decontaminate surface
- Grit blast to Sa 2.5 with 3 mil (75 µm) angular profile

1. Stripe coat all edges and welds with **ARC S2**
2. Spray two coats of **ARC S2** @ 15 mils (375 µm)
3. Apply **ARC BX2*** @ 120 mils (3 mm) on top rails

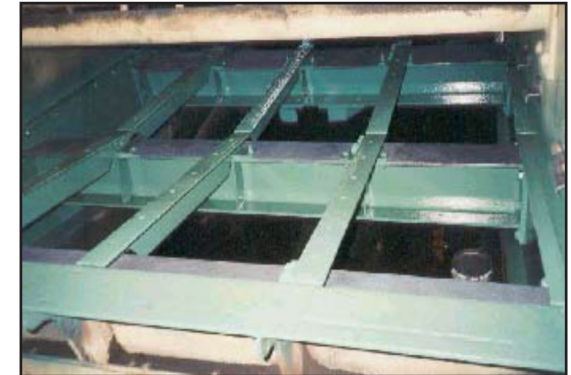
ARC BX2* applied to top rails
