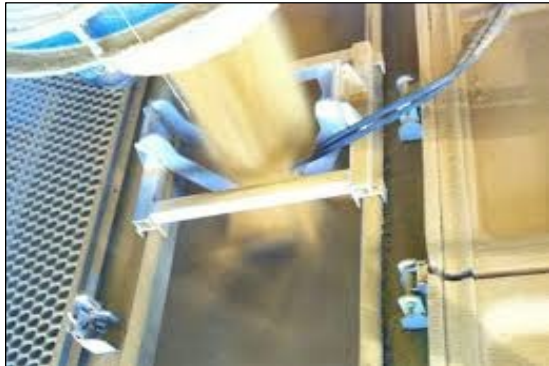
A raw corn rail car unloading its chute had severe abrasive wear that required welding or replacement every 6 – 12 months.

The impact of raw corn poured out of rail car caused impact and abrasion wear on unprotected corn chute.

*Before: chute in service.*

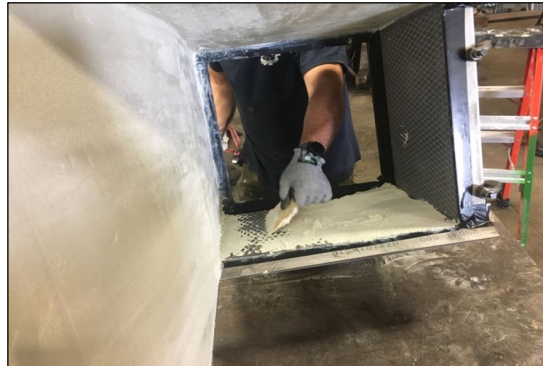
*In process: ARC MX FG being applied to prepared and tack welded surface.*

- Tack weld expanded metal to existing corn rail chute surface.
- Grit blast to surface 3+ mil angular profile.

Apply **ARC MX FG** at 3/8" nominal thickness to tack welded metal and blasted chute surfaces.

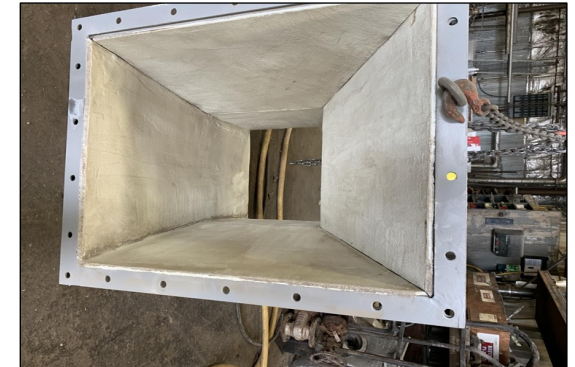
Repair performed 10, 2020. Monthly inspection of chute showed no significant wear.

*After: completed chute.*
