## Challenge

Water service cooling pipes lined with glass flake epoxies were delaminating within two years. This led to concerns about emergency core cooling components becoming plugged with loose delaminated coatings.

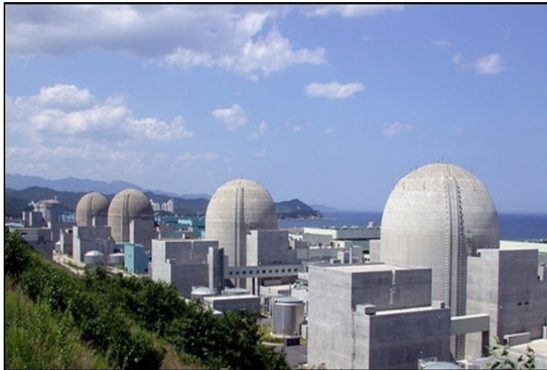
Glass flake epoxy high cure shrinkage rate accelerated blistering of coating.

Nuclear plants have unique coating requirements.

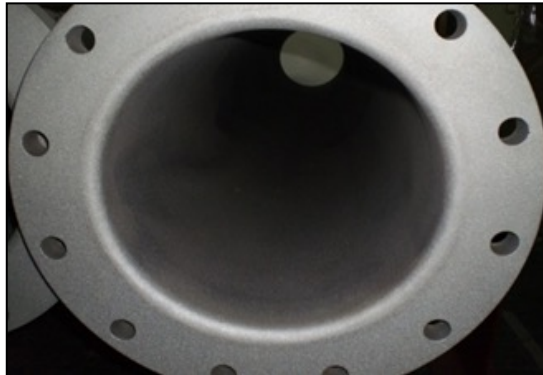
Prepped pipes after blasting.

Pipe weld quality inspected, then pipes were abrasive grit blasted to Sa 2.5 cleanliness with 75+  $\mu\text{m}$  (3 mils) angular profile.

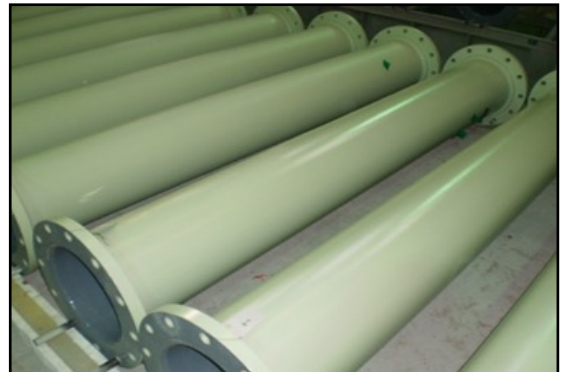
Finished pipes ready for service coating with **ARC S2**.

1. First coat: **ARC S2** green applied at 0.25 – 0.325 mm (10 – 13 mils).
2. Second coat: **ARC S2** applied within overcoat window to total dry film thickness of 0.5 – 0.65 mm (20 – 25 mils).
