Challenge

Issue

An inefficiently operating pump required unscheduled bi-monthly shutdown to replace the wear plate. Annual costs were \$21K per year.

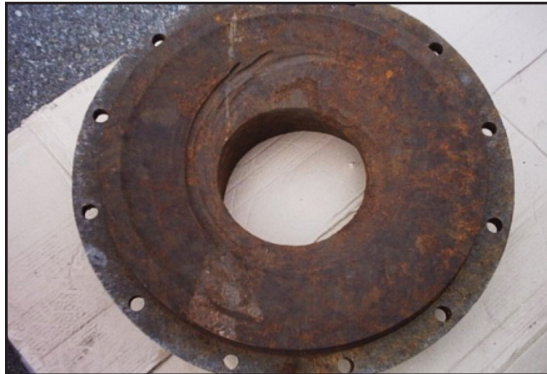
Abrasive wear of the pump wear plate from the iron powder slurry. The severe wear was a key source of the inefficiency.

Worn pump cover

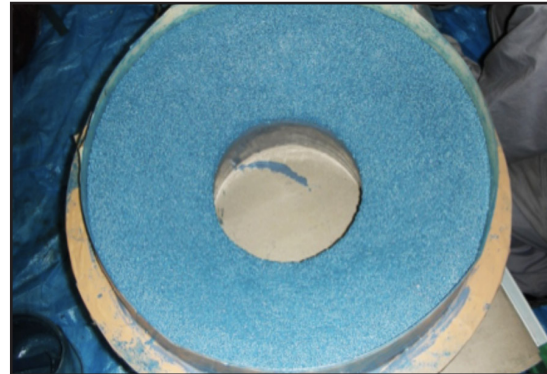
Repaired cover

- Machine back .240" (6 mm) off wear plate
- Abrasive blast to Sa 2.5 with 3 mil (75 µm) angular profile

1. Apply **ARC MX1** and machine to exact tolerance using diamond tooling

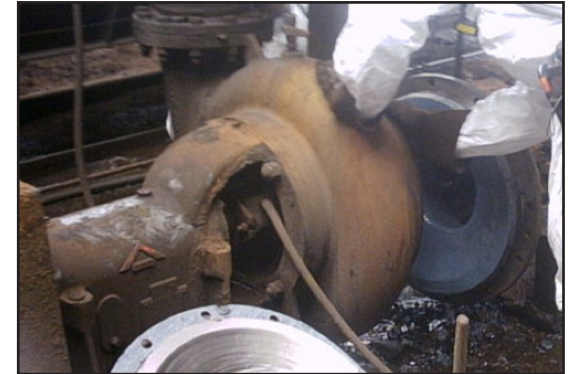
Installing coated cover with damaged cover in foreground
