Existing FRP\* linings fail in <5 years causing corrosion and chemical attack. Weld repair and relining does not meet maintenance cycle requirements.

Acid vapors attack FRP coating, exposing 304 SS impairing performance of fan.

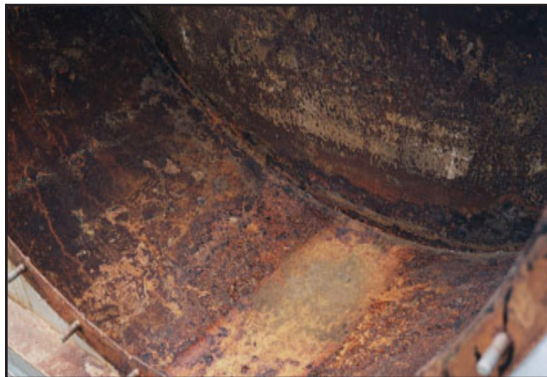
Inside the housing after FRP removal

- Hot water pressure wash 190°F (85°C)
- Grit blast to Sa 2.5 with 3 mil (75 µm) angular profile

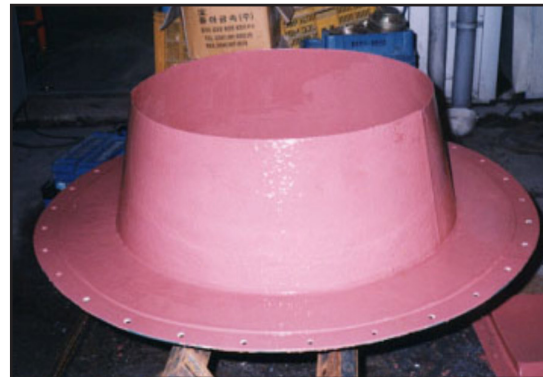
ARC S4+ applied on a housing

1. Apply 2 coats of **ARC S4+** @ 20 mils (500 µm) wft/coat with total DFT of 40 mils (1000 µm)
2. High voltage spark test @ 100 v/mil (4 v/µm)

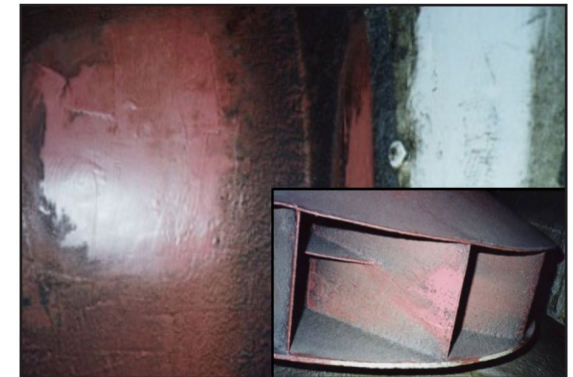
- Inspection at 9 months rated coating in superior condition
- Based on comparison to FRP at 9 months, **ARC S4+** is expected to exceed 5-year goal

Nine month inspection of S4+ shows high gloss finish remains
