Damage to carrying ring surface caused excess vibration and premature bearing failure of rake arm, requiring unplanned clarifier shut downs. Conventional concrete repair would require 21 days to complete.

Restore concrete carrying ring surface in under 10 days vs. quoted 21 days

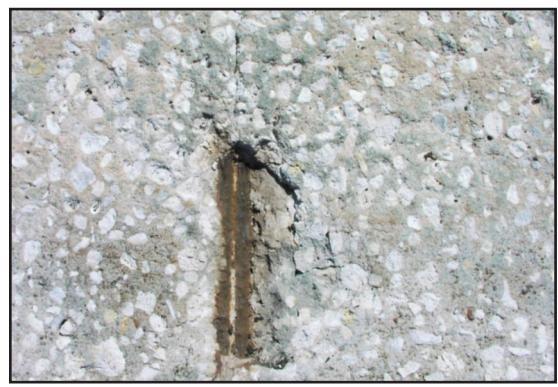
Damage from condensing  $H_2SO_4$  reacting with cement paste causing damage to concrete.

Corroded concrete with exposed rebar

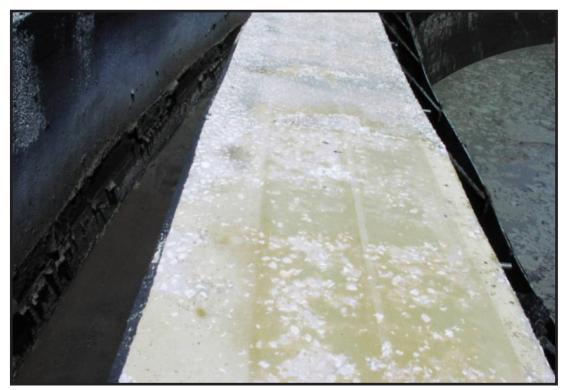
Surface cleaned and damaged concrete removed

Surfaces high pressure water blasted at 8-10k psi (535-670 bar)

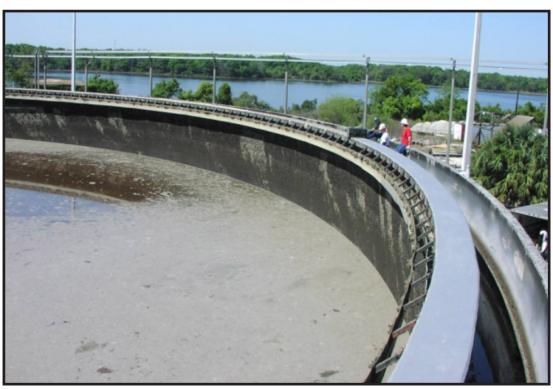
ARC 791 being applied with screed box

- 1. Screed strips installed to maintain width and flatness
- 2. Apply ARC 797 Primer by roller
- 3. Apply ARC 791 by screed box at .25" (6.4 mm) and finish with trowel
