PROTECTIVE COATINGS

SUCCESS STORIES

FOR MINING AND ORE PROCESSING
EQUIPMENT AND STRUCTURES

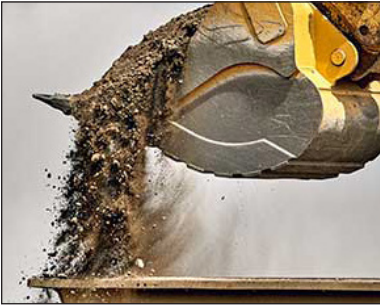
Gouging Impact Abrasion

This type of abrasion is similar to machining with a cutting tool—it cuts a deep furrow or groove into softer metal. Gouging impact abrasion effects the excavation, hauling, and primary crushing phases of mining and ore processing.

Impacts: *Drag Line Buckets, Excavators, and Crushers*

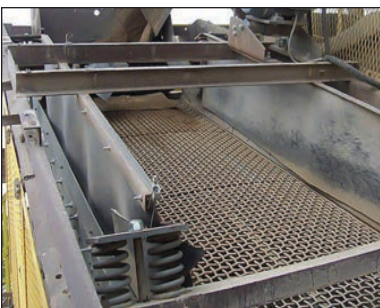
Low-Stress Scratching Abrasion

This type of wear affects the movement of slurry and other systems where particles move freely across a surface. Unless the metal is hard enough to resist, the particles cut micro furrows and grooves into the surface. Chutes, gravity classifiers, screens and pneumatic conveying systems experience this form of wear.

Impacts: *Slurry Pumps, Chutes, Agitators, and Cyclones*

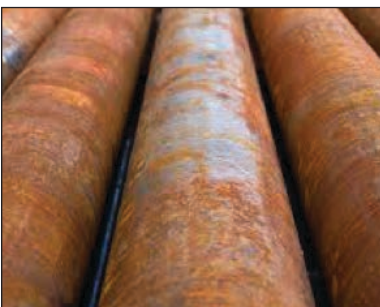
Chemical Attack Corrosion

This is probably the lowest rated form of attack on metal equipment and structures based on severity and its impact on plant performance. Electrochemical corrosion is a reaction between the surface (metallic or cementitious) and the chemical environment (fluid or gaseous). Heat will accelerate this reaction and hasten the rate of corrosion.

Impacts: *Gas Handling Fans, Ducting, Structural Steel, Secondary Containment, Drainage Sumps and Trenches*

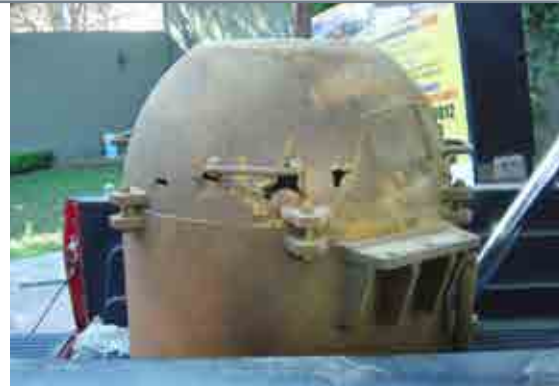
The high temperature caustic mix in mills were abrading and damaging the fiberglass and rubber linings from the OEM. Additionally, the lining adhesive disbonded and delamination occurred. The metal substrate corroded.

Worn mill after failure of rubber and fiberglass.

- Pressure wash and decontaminate surfaces
- Grit blasted to Sa 2.5 with 3 mil (75 µm) profile

1. Apply [ARC BX1*](#) in lower section
2. Apply [ARC BX2*](#) in upper section
3. Smooth out irregularities with [ARC 858](#)
4. Topcoat with [ARC 855](#) to reduce friction and protect against corrosion

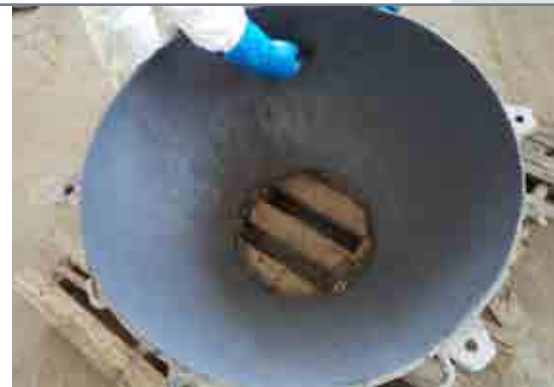
Application of ARC coatings.

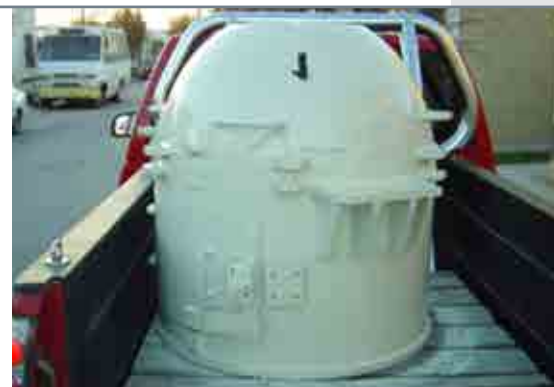
Extended MTBR of mills to >18 months
vs. 2 months

First mill after repair ready for delivery.

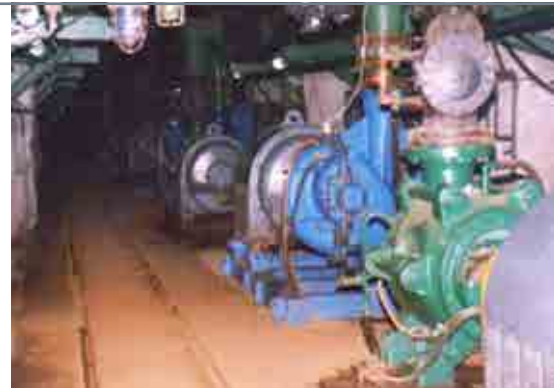
Mine production impacted by insufficient pump performance to meet required 300M³/hour flow.

Over 20,000 hours of operation in acidic mine water with entrained solids degraded the pump internals and critical tolerances.

Bank of dewatering pumps.

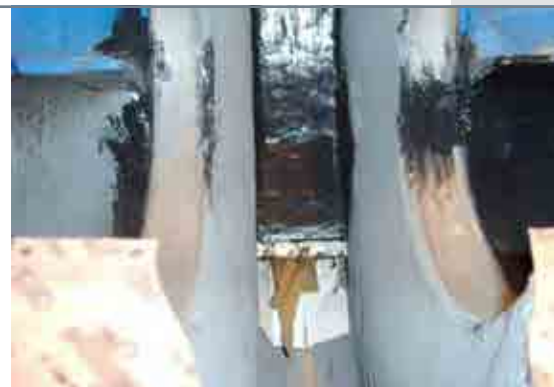
Pumps rebuilt with [ARC 858](#) and [ARC MX2](#).
Top coated with [ARC 855](#).

1. Apply [ARC 858](#) to rebuild pump back to tolerances where abrasion and erosion had damaged casing and impeller
2. Apply [ARC MX2](#) in high wear regions to address abrasive suspended solids
3. Apply final topcoat of [ARC 855](#) for additional corrosion protection and to improve flow efficiency

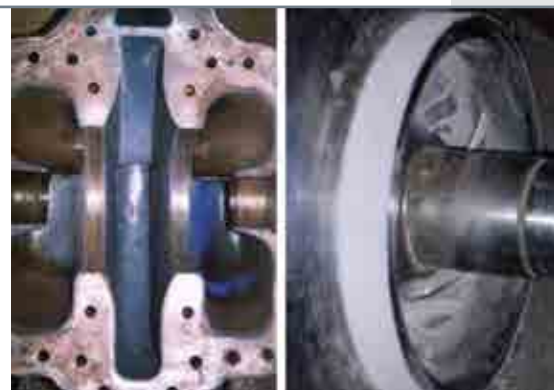
After repair, pumps operated at >94% of OEM efficiency with 3% less energy consumed.

Coated sections of pump.

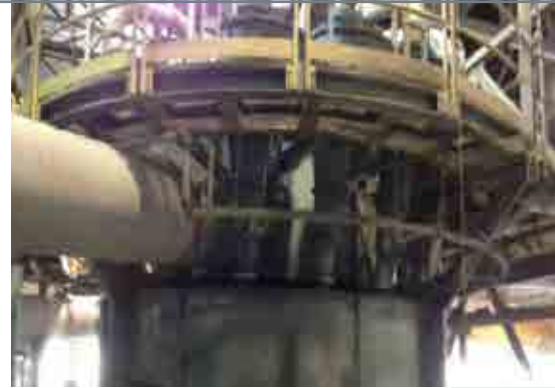
Cyclone launders experienced extreme wear at discharge after 4 years in operation. Existing rubber lining and ceramic tiles were failing to protect against high impact and abrasive flow.

High-impact flow induced slurry abrasion

Krebs Cyclone

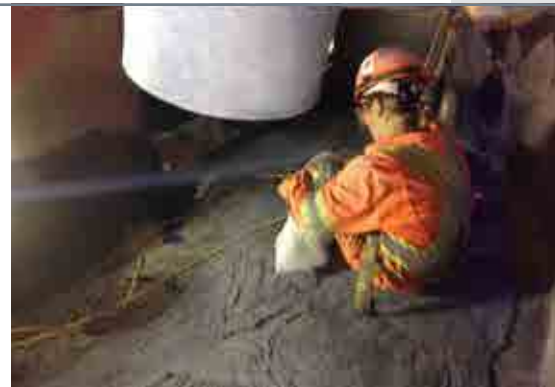
Previous product application

Apply [ARC I BX1](#) @ 0.6–0.95 cm (0.25–0.375") thickness to damaged regions

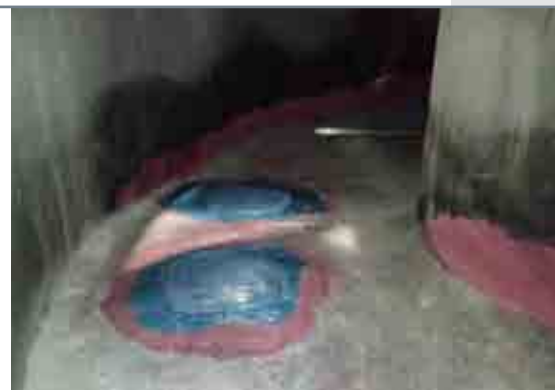
Expertly trained ARC Certified application.

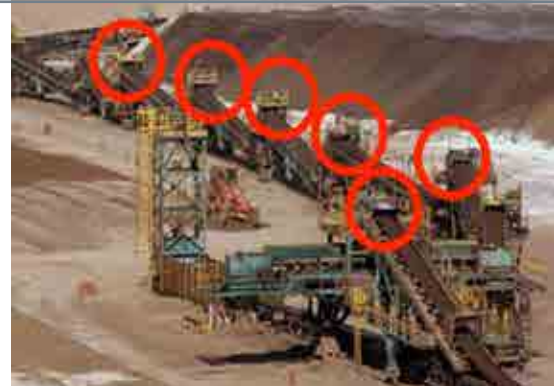
Circles indicate location of deflector chutes.

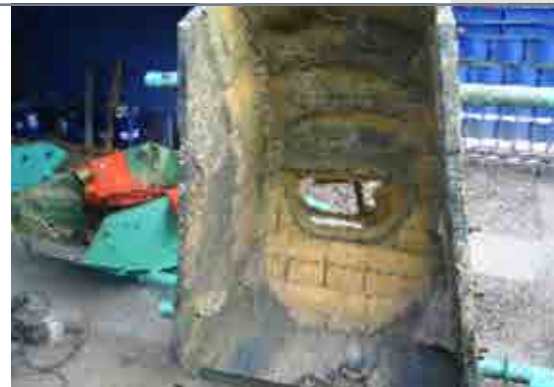
Premature wear of tile and rubber lined discharge chutes at 1,500 hours reduced development of heap leach piles, impairing enriched leachate production rate.

Highly abrasive copper ore, treated with H_2SO_4 , wears away lined chutes and perforates steel substrate.

Rubber and tile lined chute after 1,500 hours.

1. Apply [ARC BX1](#) @ 2.5 cm (1") thickness to remaining tile and rubber surfaces
2. Apply 2 coats of [ARC S2](#) @ total DFT 20 mils for reduced hang-up

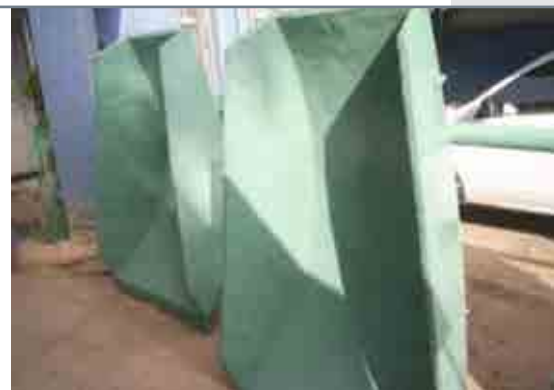
Chute life extended to > 4,500 hours (3X)

ARC BX1 coated chutes with ARC S2 topcoat.

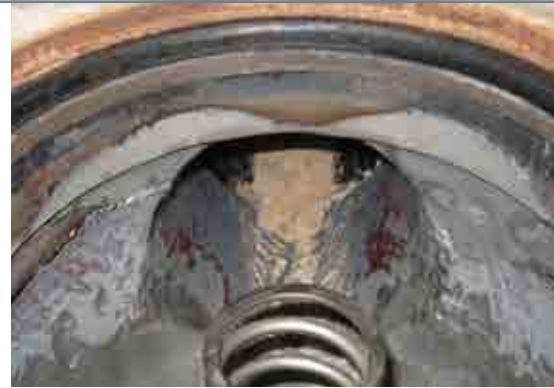
Abrasive bauxite slurry in alkali solutions at 160°F (70°C) wore previous coating, exposing base metal of valve.

Worn coating exposes metal in <3000 hours.

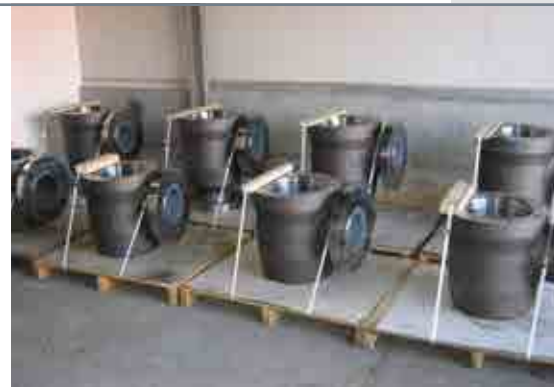
Valves machined and ready for coating.

- Machine new valves to create liner cavity
- Grit blast to Sa 2.5 with 3 mil (75 µm) angular profile

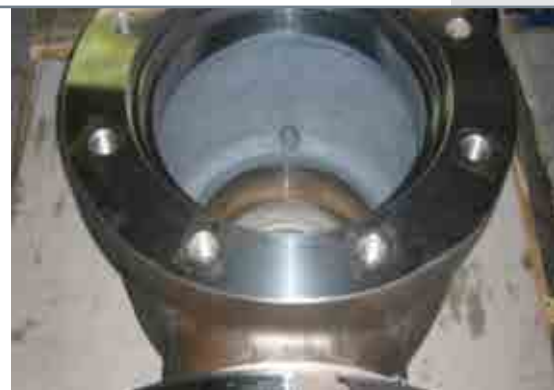
- Valve life extended to >8000 hours (2.5 x previous life)
- Worn valves can be repaired and sent back to field without need for spare parts replacement
- Ongoing application with high success

ARC BX1 coated valve

1. Apply [ARC BX1](#) to internals of valve at nominal thickness of 260 mils (6.5 mm) and re-machine to tolerances

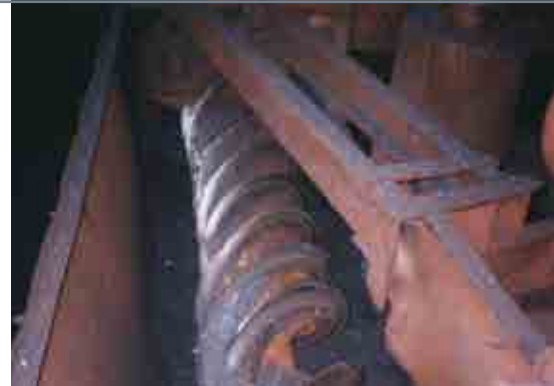
Weld repair of screws with service life of <6 months reduced throughput and affected plant operation. Weld technique resulted in scrapping of screw after 2 repair cycles due to heat fatigue stresses.

Abrasive ore wears flight faces and heat exposure from welding leads to stress cracking.

Old screw showing weld overlay repairs.

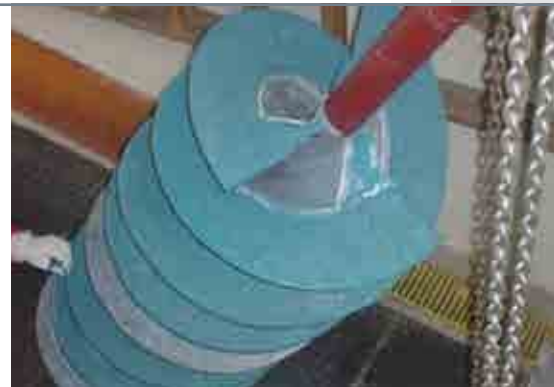
Screw during [ARC MX1](#) coating process.

1. Apply [ARC MX1](#) @ 250–375 mils (6–9 mm) to flight faces and shaft
2. Shaft to flight covered with a 500 mil (12 mm) 45° transition
3. Apply 1 coat of [ARC 855](#) @ 10 mil (250 µm)

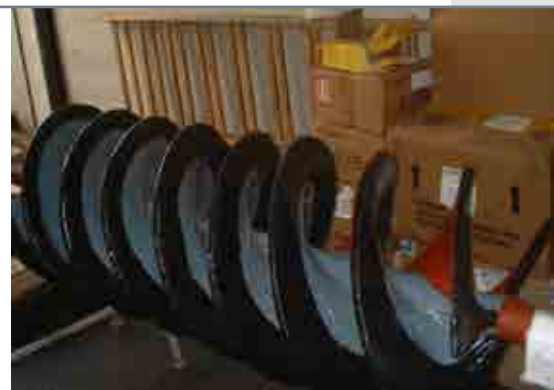
Service life extended to > 18 months with [ARC MX1](#)

ARC-coated surfaces

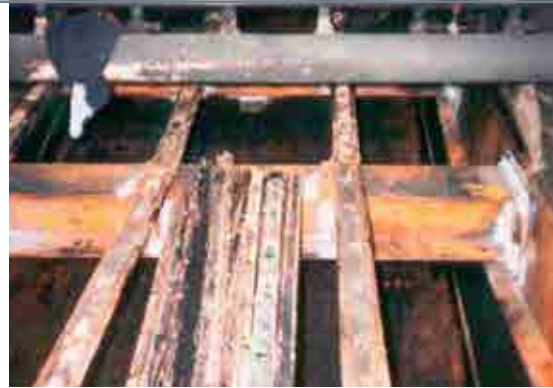
Corrosion occurs at weld seams, requiring welding within 3 years. Loss of screen deck structure can shut down plant.

Urethane liners fail prematurely. Acidic wash water combined with erosive particulates attacks exposed steel at weld seams.

Damaged coal screen

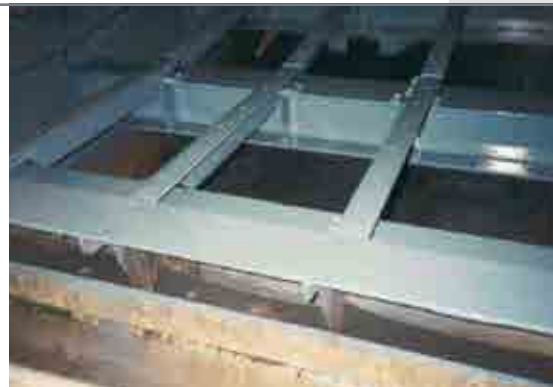
ARC S2 grey applied to coal screen

1. Stripe coat all edges and welds with [ARC S2](#)
2. Spray two coats of [ARC S2](#) @ 15 mils (375 µm)
3. Apply [ARC BX2](#) @ 120 mils (3 mm) on top rails

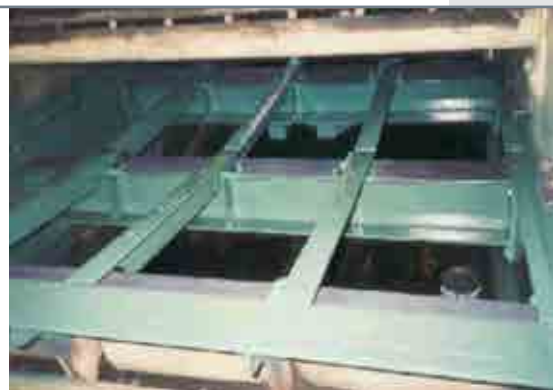
- ARC-lined screen decks have been in service for over 4 years without any required maintenance
- Service life increased by 33% to date
- Application cost reduced by 50%
- Annual maintenance costs cut by 30%

ARC BX2 applied to top rails

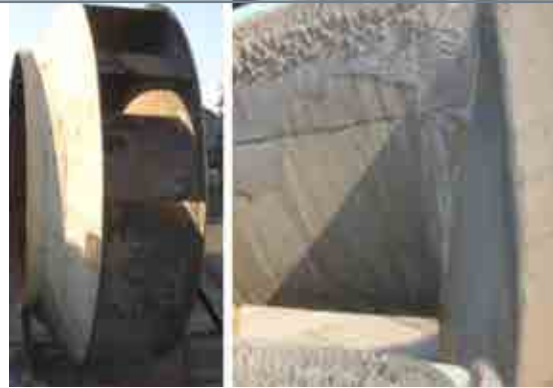
Unscheduled shutdowns due to bearing vibration failure result in production losses and increased maintenance costs.

High humidity atmosphere with chlorides corrodes fan blades and accelerates dust attachment, creating fan imbalance.

Build-up on fan blades

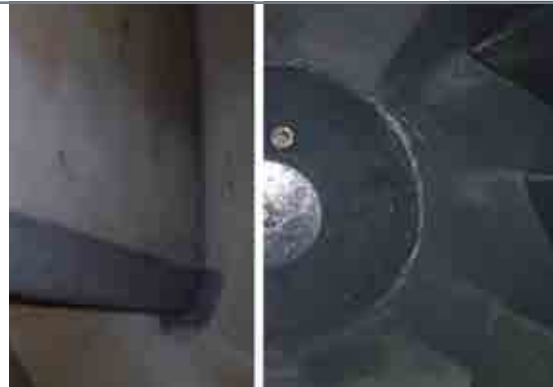
ARC BX2 applied to leading edge.

1. Apply [ARC BX2](#) @ 120 mil (3 mm) to leading edge of vanes
2. Apply [ARC 855](#) @ total DFT of 20 mil (500 µm)
3. Fan is statically balanced

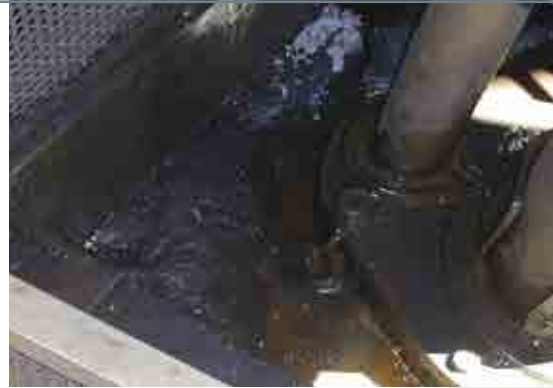
Regular spills of acid damaged the existing coating and underlying concrete after 1 year. Safety risk in traffic areas and associated environmental fines were also an issue.

30% H₂SO₄ attacks cement in concrete—damaging sumps, tank pads, and pump bases.

Pre-existing condition of concrete.

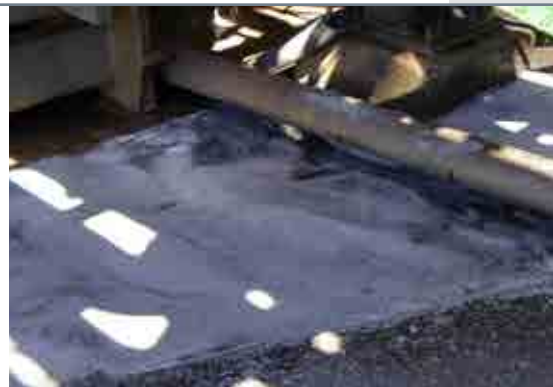
Initial application completed in 2002.

1. All surfaces primed with [ARC 797](#)
2. Pitch to grade and top coat with a 6,4 mm (0.25") of [ARC 988](#) system

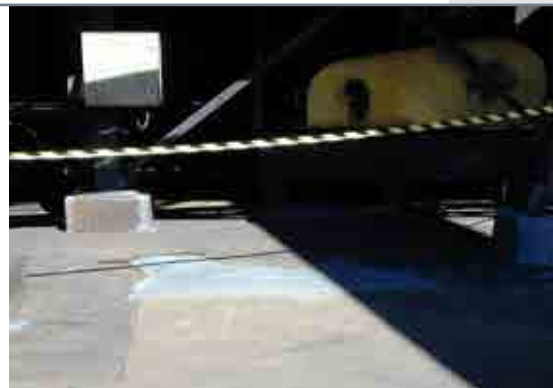
- Achieved goal of protecting concrete from acid leaks
- Safety risks from damaged concrete addressed
- ARC coated and lined surfaces are damage free for over 8 years
- Client continues to use [ARC 988](#) as preferred lining system for concrete protection in all plant areas exposed to acid

ARC coated surfaces with minimal repairs indicated in 2010.

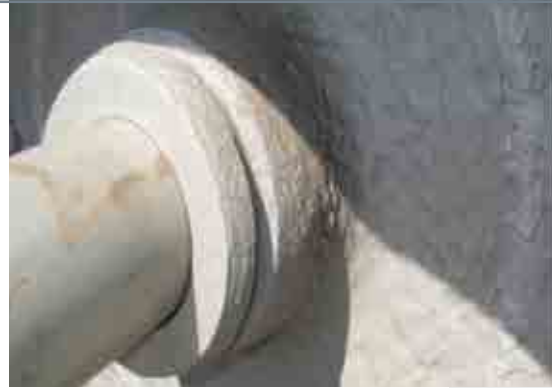
The exhaust fan required unscheduled weld repairs every 2 months and complete replacement after only 6 months. Cost and service life were unacceptable.

Corrosive exhaust gases from a smelting operation at 120°C attack the fan.

Condition of fan rotor after sandblasting.

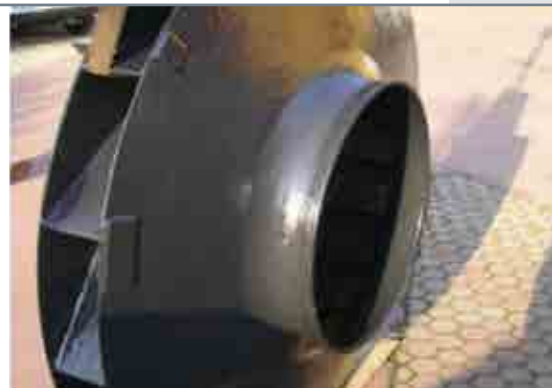
- MTBR has increased from 2 months to 6 months with inspection and minimal repairs done in field without fan disassembly.
- Fan life extended from 6 months to 3 years

Completed application to 1600 mm fan.

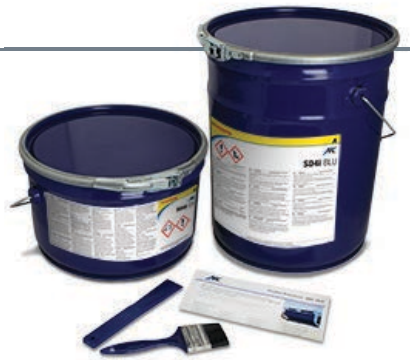
ARC 858

Abrasion-Resistant Rebuilding Coating

Upgrade new and old equipment exposed to abrasion, corrosion, or chemical attack with this 100% solids, thick film, ceramic-reinforced abrasion control epoxy compound. Use 858 to rebuild surfaces with erosion resistant protection that outperforms weld overlays. It also fills grooves, pits, etc. in metal prior to overcoating with another ARC product.

Mining Applications: *Pump Casings, Tanks and Vessels, Fans and Blades*

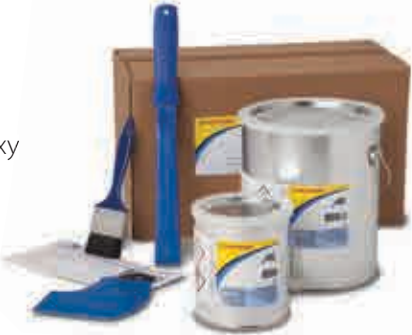
ARC BX2

Fine-Particle, Moderately Abrasive-Sliding Wear Coating

Protect areas exposed to moderate sliding abrasion. BX2 is a 100% solids, modified epoxy formulation, reinforced with a proprietary blend of ceramic beads and powders for fine particle, abrasive sliding wear environments. Use to resurface damaged metal in lieu of more traditional weld overlays. Trowel grade.

Mining Applications: *Chutes and Hoppers, Slurry Pumps, Fan Blade and Housing*

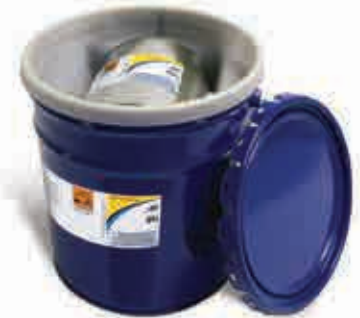
Impact-Resistant and Severe Abrasive Wear-Resistant Epoxy Composite Coating

Protect surfaces exposed to impact <math>< 50 \text{ ft lb}</math> (<math>< 68 \text{ Nm}</math>) and sliding abrasion and provide a longer lasting alternative to rubber lining and ceramic tiles. ARC I BX1 is a 100% solids, impact resistant, ceramic reinforced, epoxy/urethane hybrid coating that can be applied by trowel.

Mining Applications: *Hoppers and Chutes, Pulverizer Exhausters, Slurry Pump Cutwaters*

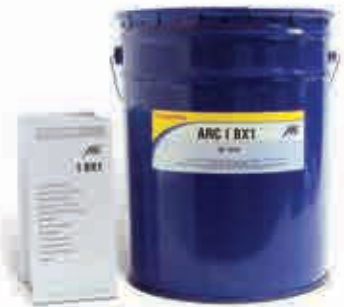
Coarse Particle, Extreme Sliding Wear and Impact Coating

Protect surfaces against dry, coarse particle erosion, wet slurry abrasion, and impact; restore worn equipment to near original condition. This coating also provides a longer lasting alternative to rubber linings and ceramic wear tiles. ARC MX1 is a 100% solids, ceramic reinforced, multi-component system formulated for extreme impact, and sliding-wear abrasion, and impact caused by medium to coarse particle flow. Trowel grade.

Mining Applications: *Pulverizers, Conveyor Screws, Dredge and Slurry Pumps*
