## Challenge

Severe pitting corrosion under the coating risked leakage of corrosive hot flue gases and slurry from the absorber.

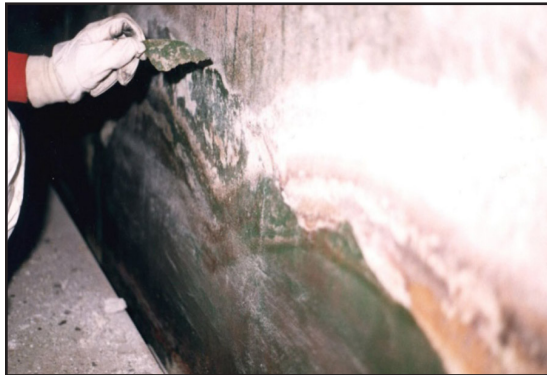
A glass flake vinyl ester lining installed less than 2 years previously had poor adhesion and was delaminating in sheets.

Glass flake reinforced vinyl ester coating delaminating from substrate after <2 years in service

- Completely remove existing lining and clean with high pH water based cleaners
- Abrasive blast clean to Sa 2.5 with 3 mil (75 µm) angular profile

- Spray apply 3 coats of **ARC S2** to DFT\* of 36 mils (900 µm)

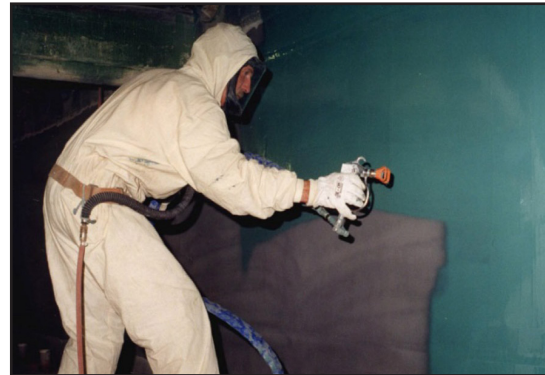
ARC S2 applied using heated plural component airless spray system

\*DFT (Dry Film Thickness) in 100% Solids Epoxy = WFT (Wet Film Thickness)

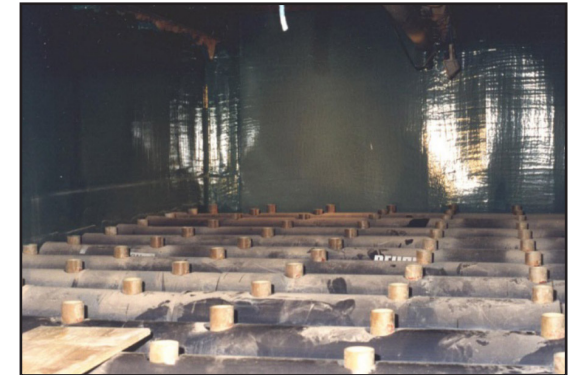
Completed ARC S2 installation in absorber spray zone and smooth surface

Client was satisfied after 4 year's service that the **ARC S2** coating had stopped further pitting corrosion of the substrate.

- 100% increase in coating lifetime with no indication degradation
- Increased availability (up-time) of absorber
