## Challenge

### Issue

Existing service life of <6 months with insufficient weld repair of screws reduced throughput and effected plant operation. Weld repair resulted in scrapping of screw after 2 repair cycles.

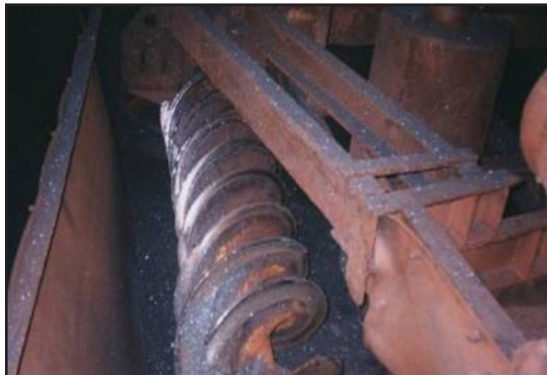
Abrasive ore wears flight faces and heat exposure from welding leads to stress cracking.

Old screw showing weld overlay repairs

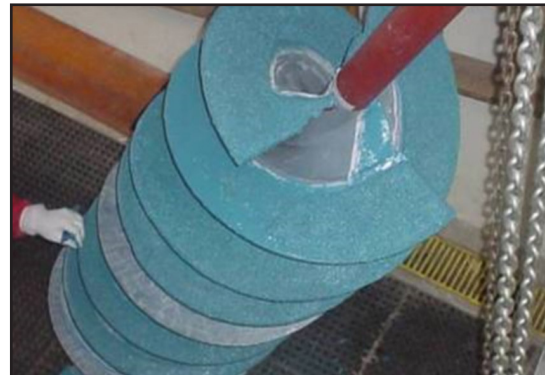
Screw during ARC MX1 coating process

- Grit blast to Sa 2.5 and 3 mil (75 µm) angular profile

1. Apply **ARC MX1** @ 250-375 mils (6-9 mm) to flight faces and shaft
2. Shaft to flight covered with a 500 mil (12 mm) 45° transition
3. Apply 1 coat of **ARC 855** @ 10 mil (250 µm)

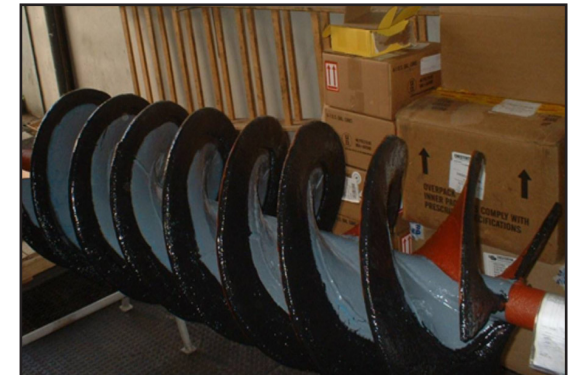
ARC-coated surfaces

- Service life extended to > 18 months with **ARC MX1**
- Cost of new screw (every 12 mo.): \$10,000
- Weld repair every 12 months: \$ 7,000
- **Total cost with ARC:** -\$ 5,000
- **Savings:** \$12,000
- Client is using **ARC MX1** in additional areas of plant including chutes, deflector plates, and hoppers
