Challenge

Issue

Chrome hardened liners wear out in <3 months and carry high spare parts replacement cost (\$240K per year).

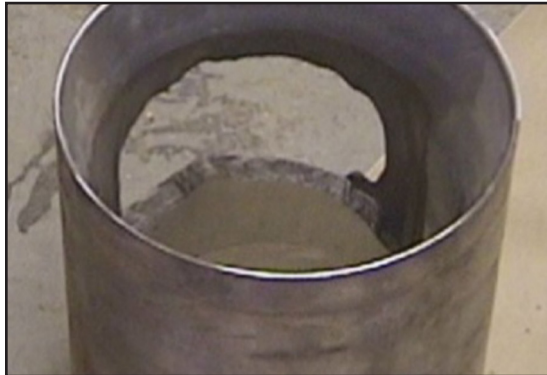
Severe high velocity abrasion from the pneumatic transport of fly ash wears liners.

Chrome liner after only 3 months operation

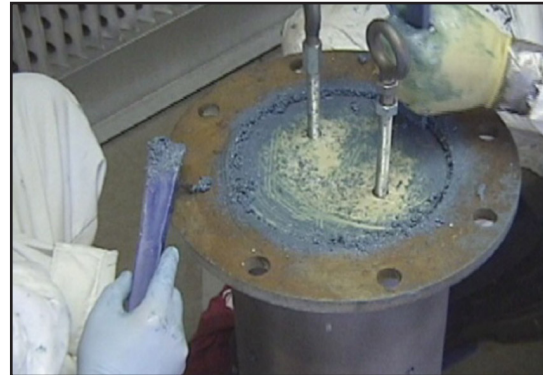
1. Fabricate urethane mold using new liner with annular gap of .75" (1.9 cm)
2. Insert mold and center in cone
3. Fill annular gap between OD of mold and ID of cone with **ARC MX1** and compact

Final stage of molding ARC MX1

- Grit blast to Sa 2.5 with 3 mil (75 μm) angular profile

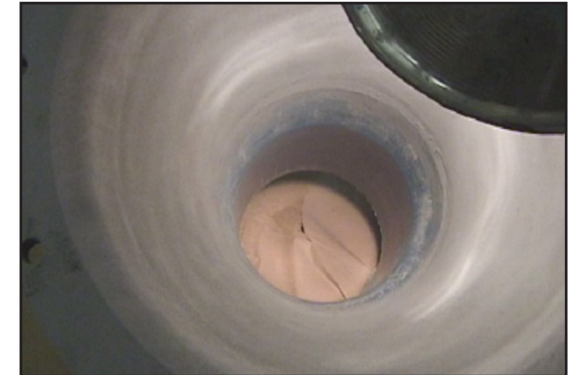
Ash cone after molding ARC MX1 in place

- At 12 months, **ARC MX1** showed no noticeable wear
- Liner MTBR extended to >36 months
- The plant has eliminated the use of chrome liners and is exclusively utilizing **ARC MX1** in all abrasion areas
