## Challenge

### Issue

Zinc rich primer/epoxy/urethane paint system required annual maintenance and touch up with increased costs and resulting damage to structure.

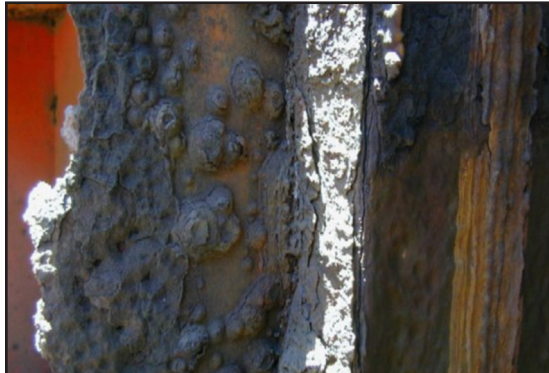
Condensing ammonium sulfate vapors on surface lead to premature blistering and delamination.

Failed paint system after 1 year exposure

- Decontaminate surfaces
- Grit blast to Sa 2.5 with 3 mil (75 µm) angular profile

1. All surfaces were coated with a two coats of **ARC S1PW** in alternating colors with a total DFT of 20-25 mils (500-630 µm)

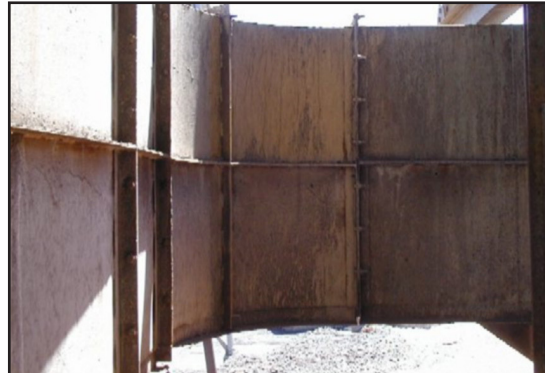
ARC S1PW applied to exteriors of ductwork

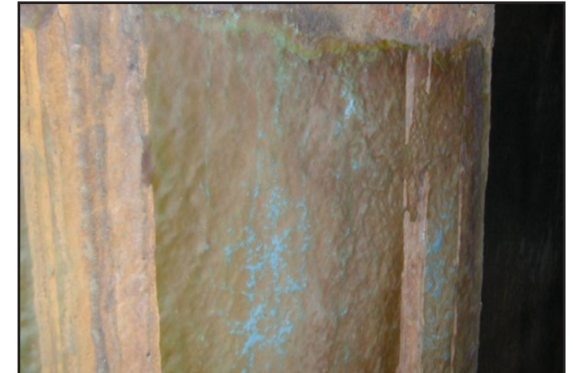
- After 18 months in service the coating shows no sign of attack other than staining which is removed with a water wash
- Client expects lining system to last >5 year and reports an annual savings of >\$50,000 due to elimination of annual maintenance painting

ARC S1PW topcoat after 1 year in service
