Challenge

Loss of ceramic tile results in abrasion and corrosion damage to structural steel requiring weld patching every 12-14 days. Maintenance shut downs (12 hrs) allow for partial patching.

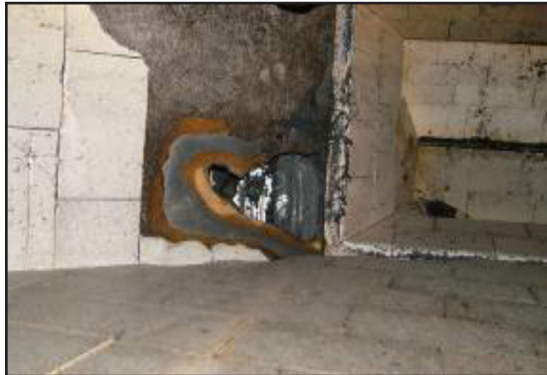
Failure of brittle ceramic tiles due to impact of coal particles as large as 4" (10 cm) diameter.

Failure of tile lined chute after 4 months prior to patch weld

- Exposed metal was patch welded
- Grit blast to Sa 2.5 with 3 mil (75 µm) angular profile

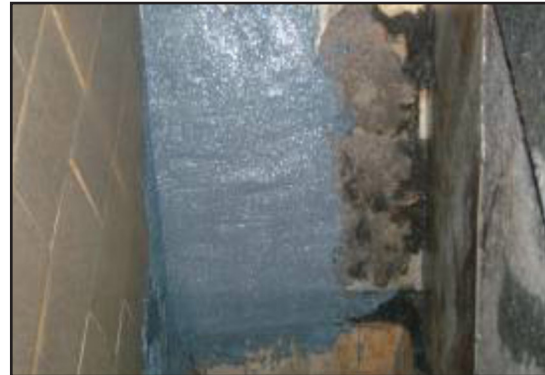
Application of ARC BX5

1. Apply **ARC BX5** @ 120-200 mil (3-5 mm) to steel and butting up to ceramic tile
2. Total repair was completed in <12 hours

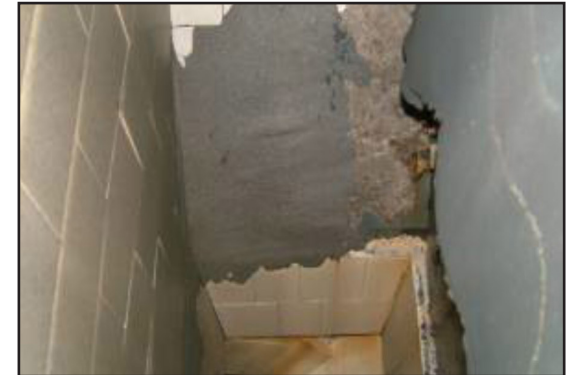
| ■ Life of ARC BX5 repair: | >7 months |

ARC BX5 after 7 months
