Internal tank corrosion is limiting its service life.

Operation conditions with condensate (demineralized water) and temperature (230°F/110°C) are highly corrosive for the carbon steel tank.

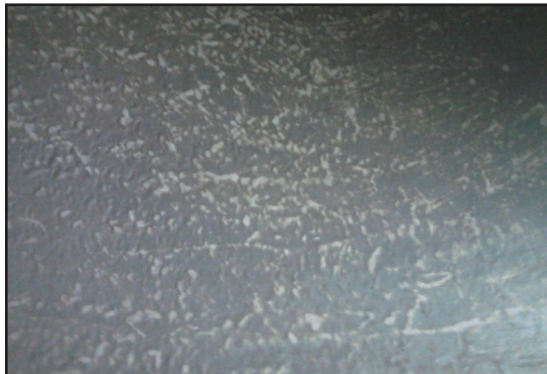
Corroded tank internal surface

- Wash surfaces with hot water
- Grit blast to Sa 2.5 with 3 mil (75 - 125 µm) angular profile

1. Apply **ARC HT-S** in a 2 coat system @ 20-24 mils (500-600 µm) final thickness.

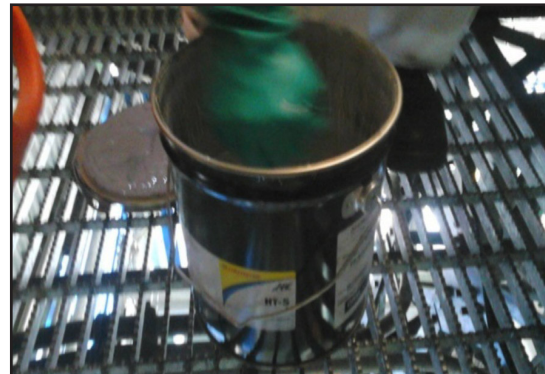
Product mixing

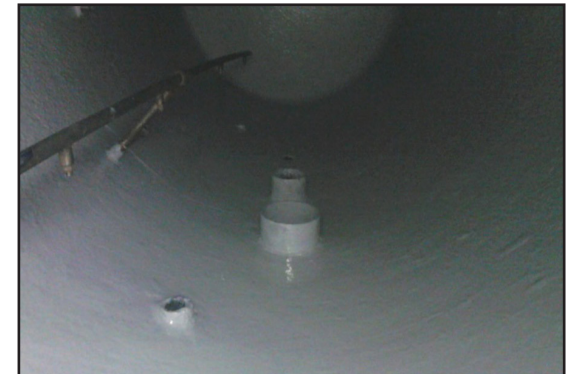
Coated tank internals
