## Challenge

Coal pulverizers experience unscheduled shutdowns due to impact damage to tile liner. Alternative coatings lasted <1 month

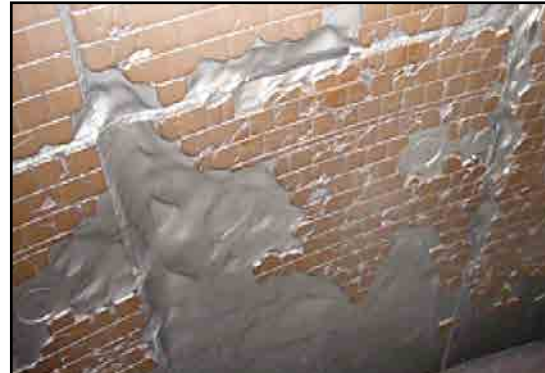
High velocity coal fines impacting brittle ceramic tile

Damaged pulverizer walls

- Power tool clean to SP 11 with 2+ mil (50 µm) angular profile

- Apply 240-375 mil (6-9 mm) **ARC I BX1 RC** during a 12-hour shutdown to damaged areas butting up to remaining tile

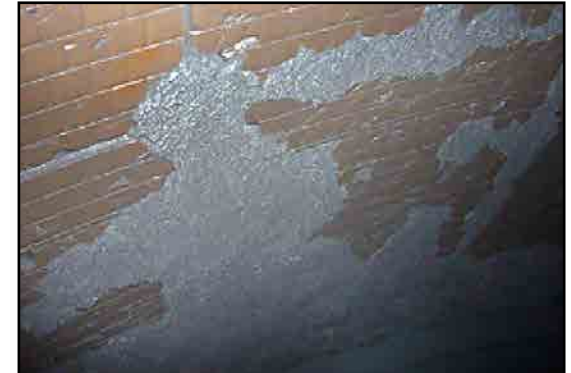
- Inspection after 1 month showed 95% or product thickness remained and zero delamination

Coated pulverizer after 1 month
