Challenge

Issue

A food plant customer frequently cleaned the floor area where foot and heavy forklift traffic occurred. During power washing the concrete spalled and created a trip hazard.

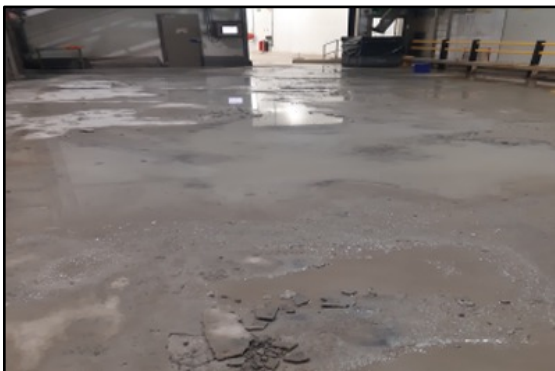
Heavy traffic and frequent pressure washing resulted in concrete spalling.

Floor condition with concrete spalling.

The damaged area was cleaned and all loose concrete was removed. The “key cuts” were made to ensure a tightly sealed surface to prevent feathering at the edges.

ARC EG-1 Grout Resurfacer was applied in a single application directly to the prepared concrete at a thickness ranging from about 1 cm – 5 cm (0.4" – 2"). It was keyed into the existing floor providing a level surface with no trip hazard.

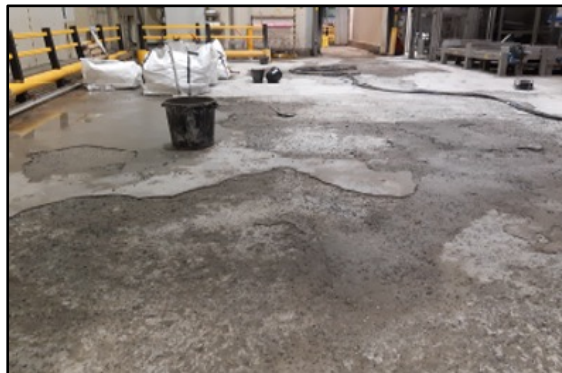
Surface preparation before ARC EG-1 is applied.

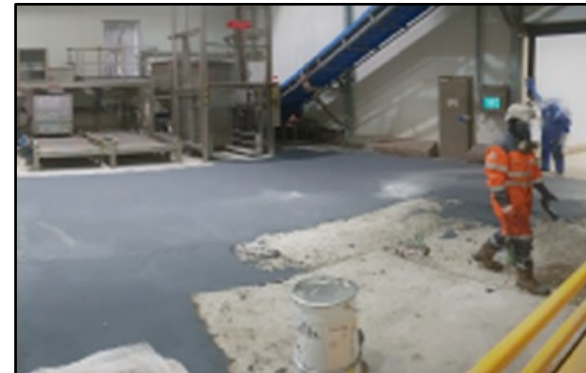
After two months in service, the ARC EG-1 is resisting the heavy forklift traffic and daily clean down procedures in this area. Client is very pleased with the inherent slip resistant surface that the ARC EG-1 product provided.

Floor after ARC EG-1 coating is installed.
