A major mine owner was experiencing premature failure of the arm cylinder on a Demag excavator leading to unplanned downtime and lost production.

Demag excavator – Model H485.

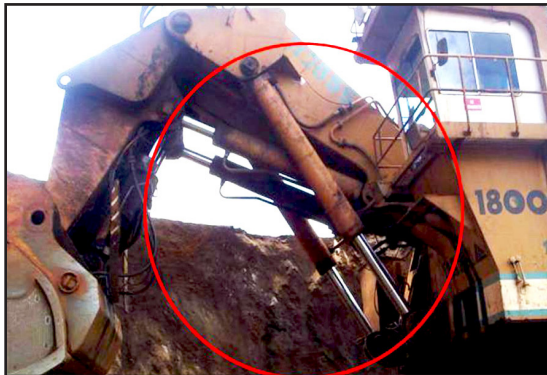
The OEM rubber seals were leaking shortly after installation. Severe leakage led to replacement, on average, after only 48 days.

Upon inspection, the wiper and rod seals were found to be damaged and could not withstand the severe hocking loading this equipment was exposed to.

Chesterton's local specialist recommended a cylinder upgrade solution that included a high-performance wiper used in combination with a rod seal and anti-extrusion ring.

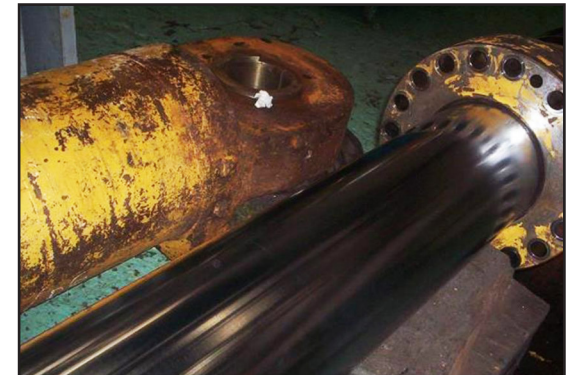
The Chesterton sealing solution extended the rebuild cycle from 48 days up to 160 days during the evaluation period by the mine.

Arm cylinder was in excellent condition upon inspection.

The sealing solution was specified as the standard offering for all future rebuilds of this equipment based on its performance.
