## Challenge

A large surface copper mine experienced premature seal and cylinder failure on the stick cylinders of a large mining excavator.

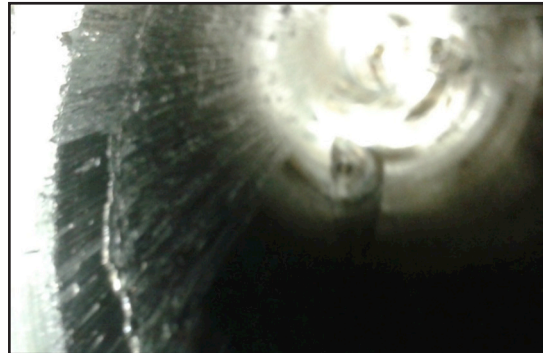
Stick cylinders were exposed to severe operating conditions including shock and radial load, pressure peaks, and a harsh environment.

Cylinders lasted only 4,000 hours with their original seal repair kit.

Damaged cylinder bore.

The Chesterton specialist recommended a cylinder upgrade solution in co-operation with a local cylinder repair workshop. Chesterton's custom seal kit was installed.

- All seals were made of **AWC860** polymer, Chesterton's exclusive high-temperature polymer.
- The sealing solution included a **21K** wiper, **22KE** rod seal, **20KB** buffer seal, **20K** piston seal, **20KD** static seals, trash rings, and bearing bands.

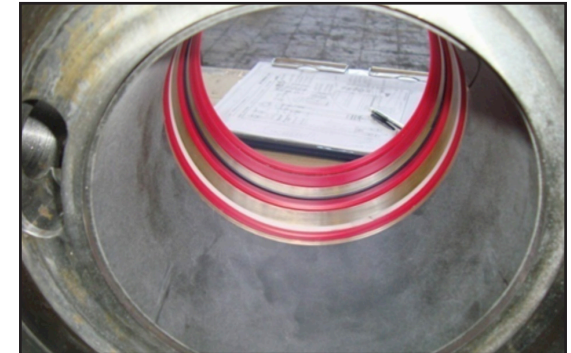
Chesterton rod seal system installed.

- Seals lasted 9,000 to 13,000 hours of continuous operation vs. 4,000 hours with original seal.
- Increased the availability of critical equipment for production.
