David Larson,
A.W. Chesterton Co.,
US, outlines a simple
approach to improving
bearing reliability.

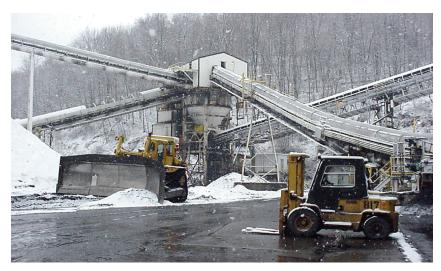
Figure 3. Coal conveyors.

At a coal preparation plant, frequent bearing failures on the tail roller conveyor system were due to inconsistent lubrication practices, average quality greases and poor bearing seal protection. The typical challenges were what type of grease should be used, concerns of over- or under-lubrication, the volume of grease needed, the frequency of lubrication, the dangerous location of grease points and limited manpower. All these factors contributed to inconsistent bearing lubrication,

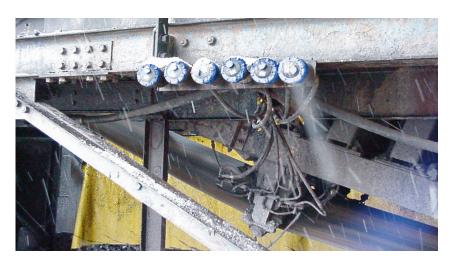
Figure 4. Single point grease lubricators feeding primary bearings.

A high performance calcium sulfonate grease with extremely low water washout, high EP and corrosion protection was combined with a gas-operated, single point lubricator. Standardising on one lubricant eliminated the need for multiple types of greases for different applications. The single point lubricators solved the other issues by being user friendly and simple to operate, having a variable dispensing rate, a sealed microprocessor/logic circuit for dependable operation and, most importantly, provided an affordable system approach to lubrication maintenance.

The replaceable lubricators were located between 5 – 10 ft from the bearings where they were removed from rotating parts, making it easy to inspect and maintain the units without interrupting the operation of the conveyor line. A single lubricator

The grease feed rate depends on the bearing diameter and revolutions per minute (RPM). The dispenser suppliers normally provide charts to determine the feed rate setting. In this case, 250 cc of grease provided lubrication for each bearing for 6 months. At this point, the units would be shut off and replaced without interrupting production.
