Challenge

At a food manufacturing plant, containers are filled using equipment with multiple filling heads that use an air cylinder to open and close filling tube valve.

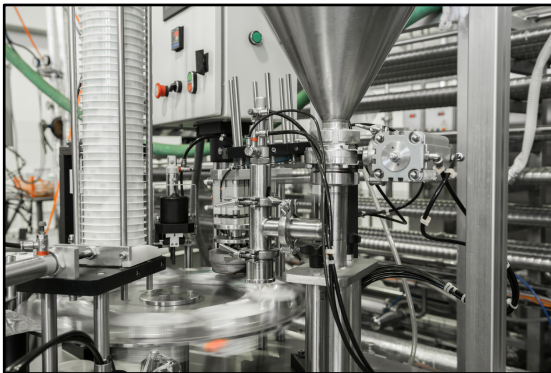
Multiple filling heads must deliver a precise quantity of product into the container. Cylinder lag time causes variance in fill weights.

Due to frequent washings, water was able to get past cylinder wipers into the cylinder. This resulted in corrosion and gum formation that caused actuation delays.

High speed filling line.

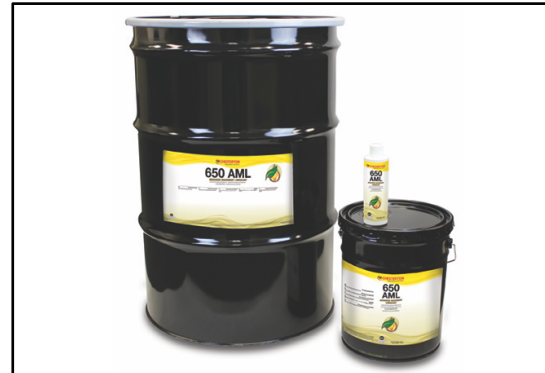
650 AML was simply added into the in-line oiler.

A local representative recommended Chesterton 650 Advanced Machinery Lubricant, a pneumatic lubricant for its water absorption capabilities. Its excellent emulsification characteristics can absorb water in the pneumatic systems, avoiding corrosion and residue formation.

The in-line lubrication system was cleaned of the old white oil, and water was drained from filters. 650 AML was filled in the top oil bowl of the pneumatic lubrication system.

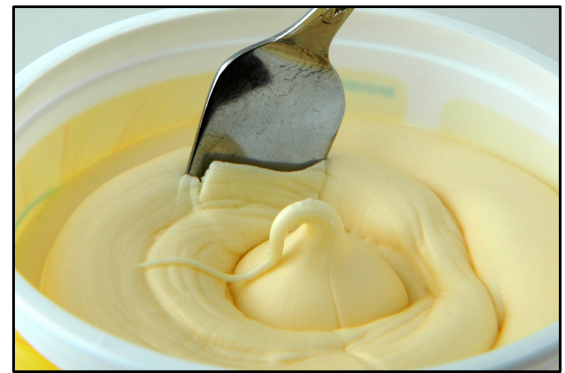
Enhanced reliability with 650 AML insures a smooth operation.

- The 650 AML has been in operation for 12+ weeks without any issues.
- Actuators have been working flawlessly and no line stoppage has been observed.
- Solenoid valves did not need any repair or replacement.
- Fill weights and final packaging specs have been accurate.
