## Challenge

### Background

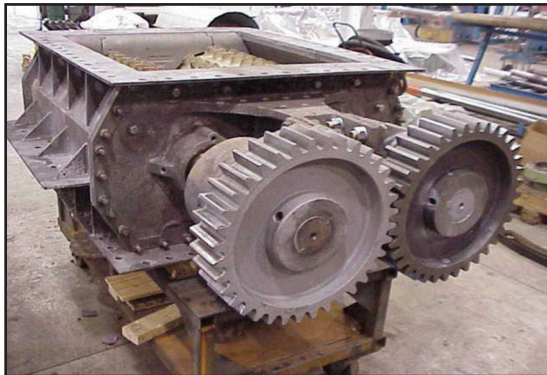
- Power plant was experiencing damage that resulted in loss of efficiency and productivity in a klinker grinder unit.
- Damage to the klinker was caused by water exposure, abrasive conditions, shock loading, and the lack of lubrication.
- The klinker presented constant leakage
- Typical unit rebuild costs due to bearing failures were \$23,600 annually per grinder unit.

Initial condition of klinker grinder.

Complete grinder rebuild and upgrade using **Chesterton 1730 Mill Pack**, SpiralTrac type “P” stuffing box bushing, and **Chesterton style 5500 Live Load disk spring washers**. The bearing housings were also upgraded to labyrinth seal bearing protection and **Chesterton Lubri-Cup™** Automatic Lubricant Dispensers with **615 HTG #2** grease.

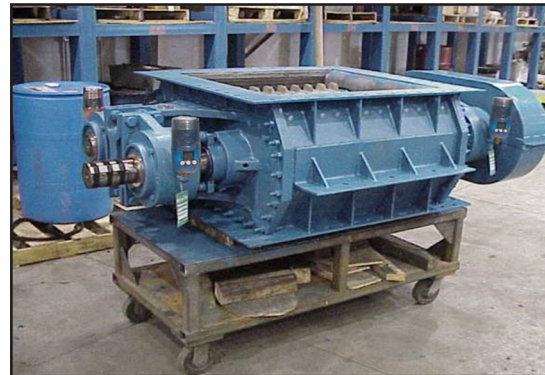
Klinker after Chesterton solutions were applied.

- After three months, the klinker grinder had minimal leakage, smooth operation, and no maintenance issues
- It is estimated that this upgrade will double the grinder’s service life and drastically reduce on-going routine maintenance costs.
- Based on parts and labor savings it is estimated this will save the plant over \$47,200 yearly, per grinder unit.

All fasteners were coated with **785 Parting Lubricant** throughout for ease of assembly and disassembly.

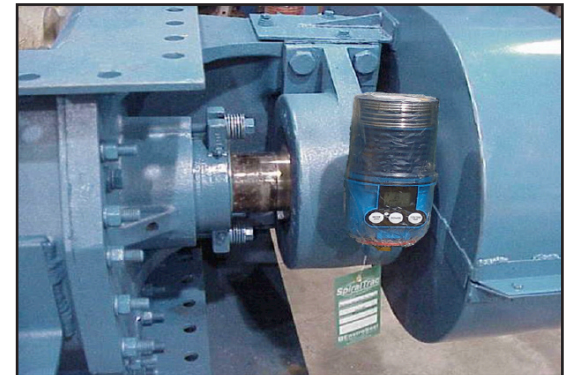
Closeup of Chesterton Lubri-Cup Automatic Lubricant Dispenser.
