Challenge

The infrastructure of a suspension bridge at the coast is subjected to extreme humidity, temperatures, and corrosive environments.

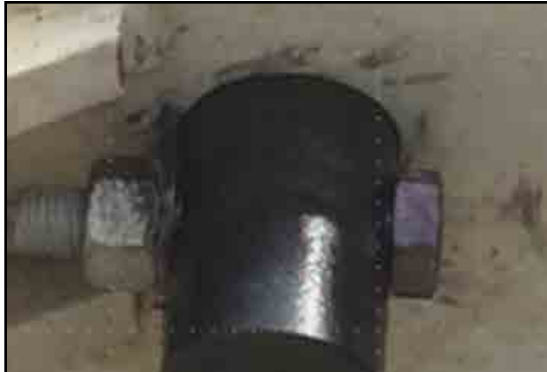
The pins, which are part of support structure, become prematurely corroded over time, which can compromise structural integrity.

Corroded support pins.

The corroded parts were treated with **Chesterton 763 Rust Transformer**, a mild acid-based product that transforms rust into a stable and corrosion-inhibiting surface.

The treated parts were then coated with **Chesterton 752 Cold Galvanizing Compound**, which provides anodic protection in atmospheric or corrosive conditions.

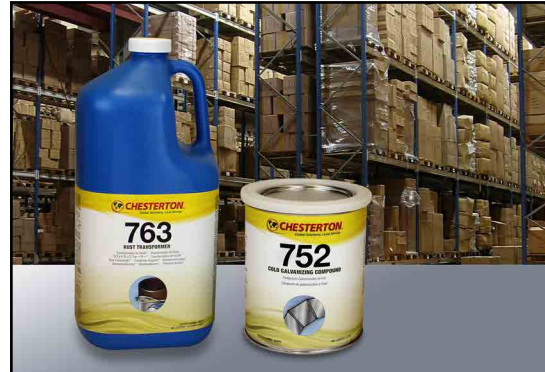
Chesterton's 763 and 752 restore and protect metal parts.

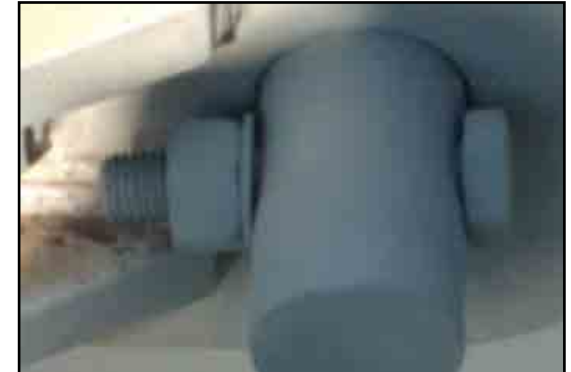
The pins were successfully restored and protected from further corrosion.

- With **763 Rust Transformer**, rust on the parts was electrochemically transformed into a protective layer that inhibits corrosion.
- The ultra-fine particles of the **752 Cold Galvanizing Compound** act as a sacrificial coating. The anodic zinc becomes oxidized instead of the base metal.
- Structural integrity was restored as a result of the **Chesterton 763** and **752** combined solution.
