## Challenge

### Background

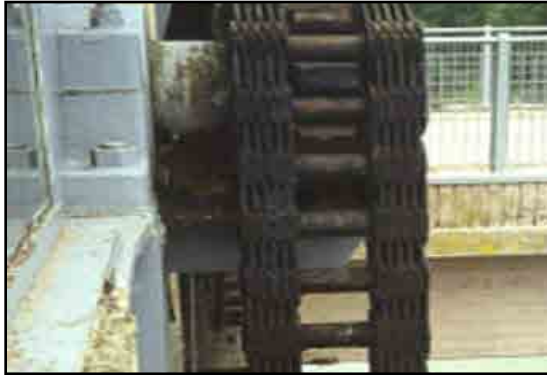
The water level control gate at the dam is chain actuated, and the chain was heavily contaminated. As a result, the chain did not run smoothly and efficiently.

*The chain was heavily contaminated.*

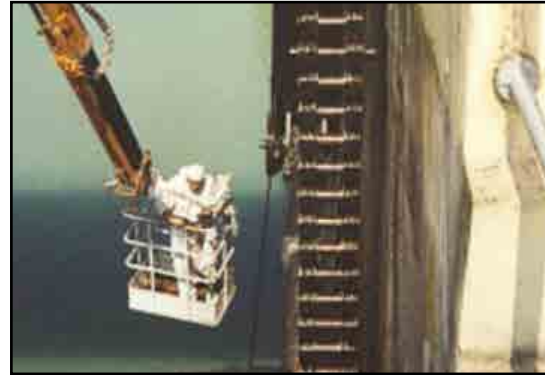
*Three products cleaned and restored the chain.*

A 10% concentrate of biodegradable **Chesterton 803 IMS II** was applied to the chain. The biodegradability of the cleaner minimized waterway contamination. **Chesterton 601 Chain Drive Pin and Bushing Lubricant** was applied to provide penetrating lubrication, and **Chesterton 715 Spraflex® Gold** was applied for exterior lubrication and corrosion protection.
