## Challenge

A European oil refinery experienced major issues with heat exchangers which caused frequent emergency repairs between plant stops. Flange springs were replaced with every shutdown.

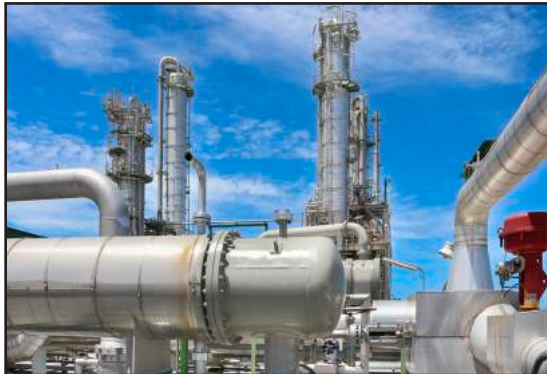
Heat exchanger emergency repairs impaired production.

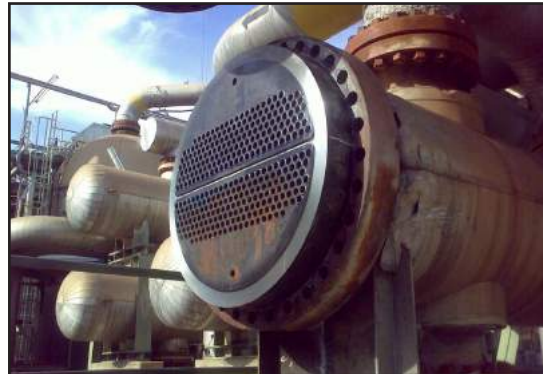
- Solves leakage often seen when bolted, gasketed joints are subject to mechanical shock, pressure surges, and/or thermal expansion and contraction
- Compensates for poor conditions by maintaining bolt force
- Results in extended reliability and equipment life

Live loading resolved customer's issues.

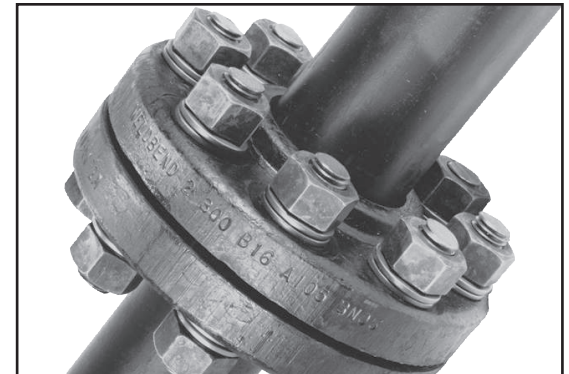
Keeps flanges leak free by maintaining tension on bolts between plant shutdowns.
