Challenge

Background

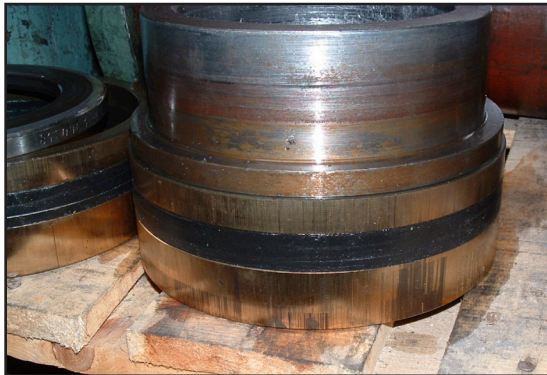
A major aluminium extrusion plant owner experienced premature piston seal failure in the side cylinders of a 3500T extrusion press, leading to unplanned downtime and lost production (24/7 continuous operation). The OEM fabric-reinforced rubber stacked sets were damaged shortly after installation. This caused hydraulic oil by-pass in the cylinders. Upon inspection the piston seal sets were found to be damaged and could not withstand a high sliding speed 0.8 m/sec (160 ft/min) and pressure 32 MPa (4640 psi).

Damaged piston seals and piston head

Chesterton specialist provided an upgraded piston seal system. An upgrade to the mechanical guidance of the piston head was part of the project, using high bearing-load capacity non-metallic wear rings.

- **P28K1 V-Ring Set:** Solid multi-lip design provides tight, leak-free operation improving hydraulic equipment efficiency
- **16K Wear Rings:** Guide the piston head and eliminate metal-to-metal contact
- **AWC800 Seal Material:** Offers outstanding high-pressure and sliding speed handling capability.

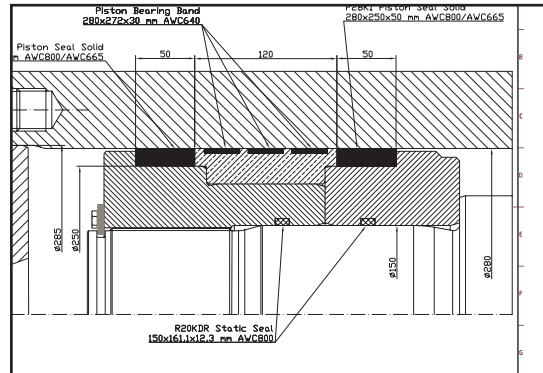
Heavy duty piston seal system

The Chesterton seal solution extended the cylinder rebuild cycle from 6–8 months to 20–22 months
