Challenge

Paint from paper machine frame peels off and effects production quality of white Kraft paper requiring repainting of machine frame every 12-18 months.

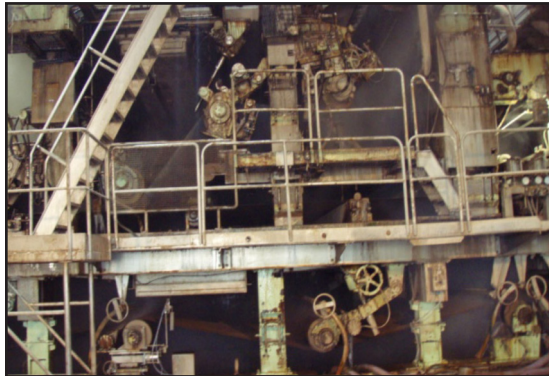
Constant surface exposure to water, chemicals, vapors, and high temperature effects protective coating and leads to delamination.

Corroded structure of old paper machine

- High pressure water wash to remove old coating
- Grit blast to Sa 2.5 and 3 mil (75 µm) angular profile

1. Apply two coats of **ARC S1** in alternating colors with @ 20-25 mils (500-630 µm) total DFT

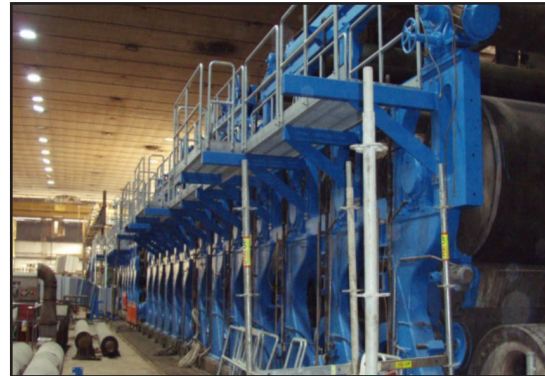
ARC S1 applied to frame during refurbishment

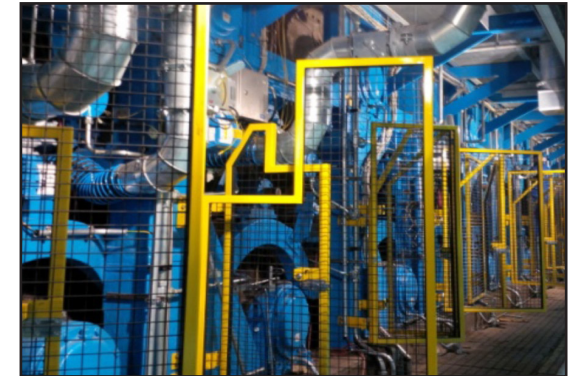
- Life of ARC solution exceeds >7 years (4.5X previous coating)
- Eliminated production losses
- Halted machine frame corrosion

PM7 structure coated with ARC S1
