Challenge

Issue

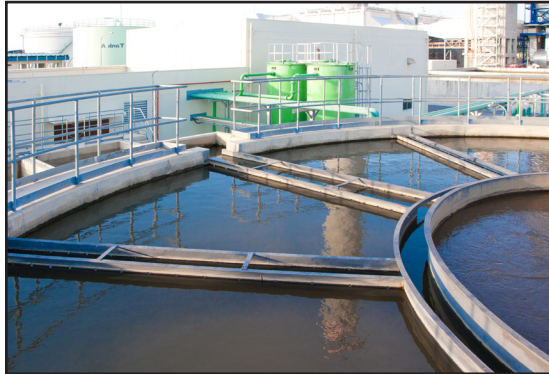
Condition of 1st tank coated with ARC 858 and ARC S1PW after 11 years in service.

The first tank coated has now been in service for 11+ years with very few signs of failure. Two additional tanks were coated in 2016 and 2021.

All surfaces were HP water washed, tested for chlorides, and then grit blasted to Sa 2.5 – 3 cleanliness with 3 – 5 mil profile.

Chesterton® ARC 858 was applied to the heavily pitted regions and weld zones where the corrosion was most severe.

Two successive 10 – 12 mil coats of Chesterton ARC S1PW were applied by airless spray.

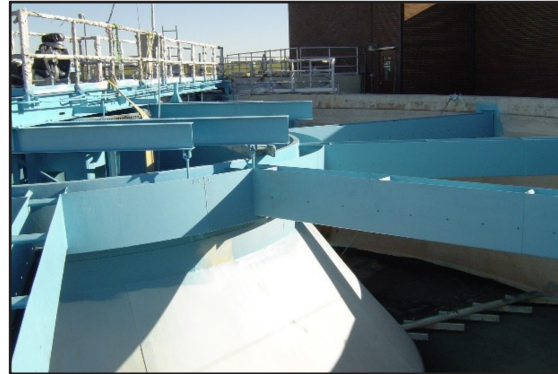
ARC S1PW blue being applied over ARC S1PW white.

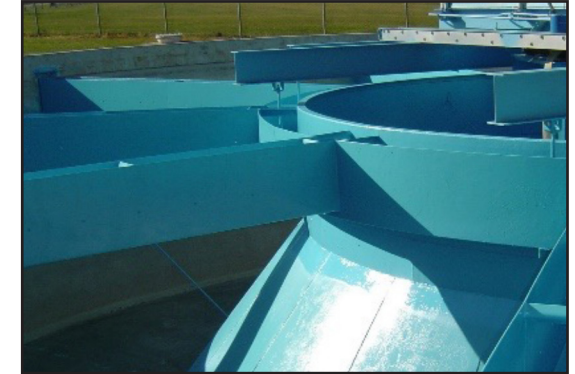
ARC S1PW can be applied by brush, roller, or spray.
